# TX-DS797 and TX-DS898

Preparation to work or troubleshoot on DSP as well as possibly power amplifier or other input function PCB assemblies. The process will take 3 to 8 minutes.

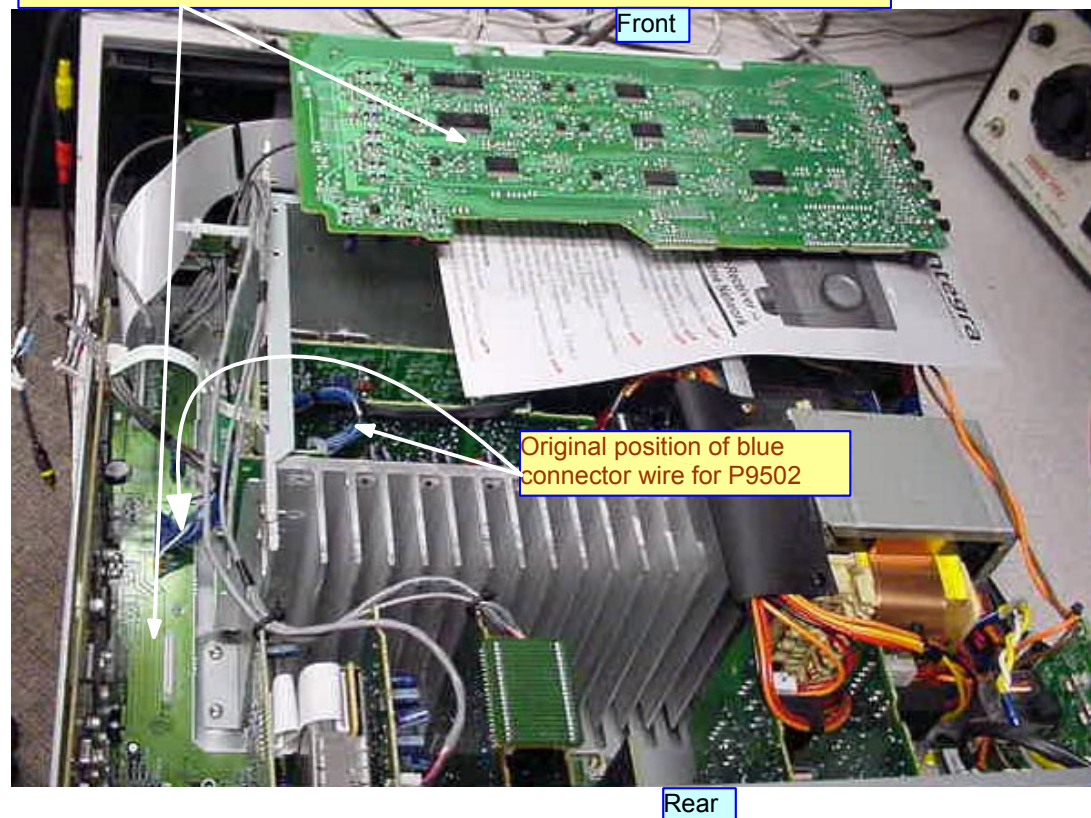
Pre-amplifier PCB / Volume is removed to create troubleshooting access for the DSP component side.

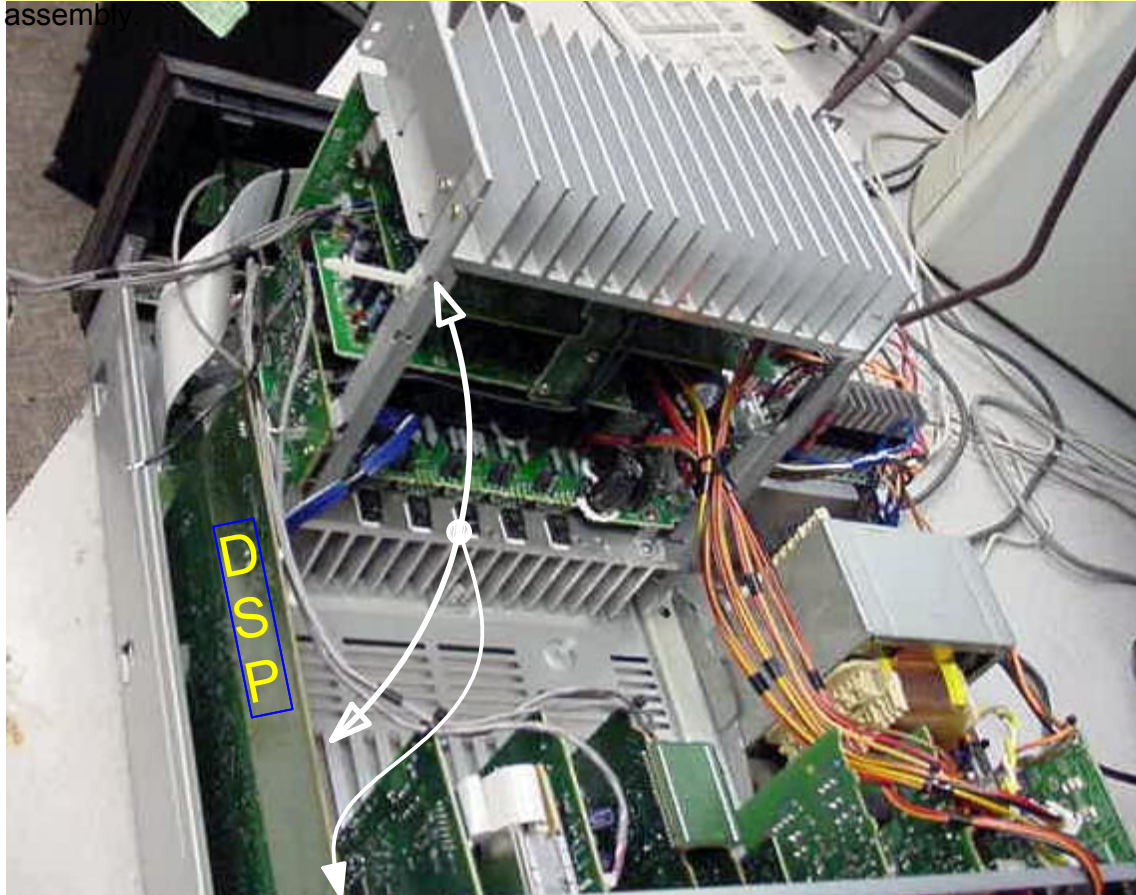
Disconnect P9502 connector wire (Blue) and then remove all 8 screws holding heat sink to the bottom chassis. Remove white ribbon connector from P7701A DSP side. Disconnect all speaker connectors from P6810, P6812, P6008A and P6008B. Remove secondary power connector from P6951 location found on power relay PCB assembly.

Set power amplifier on it side as seen above.

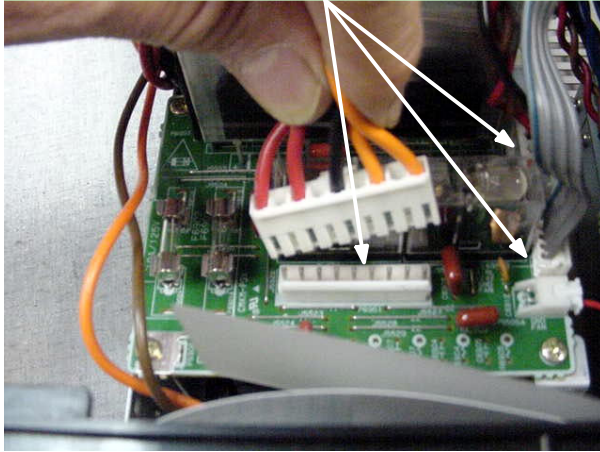
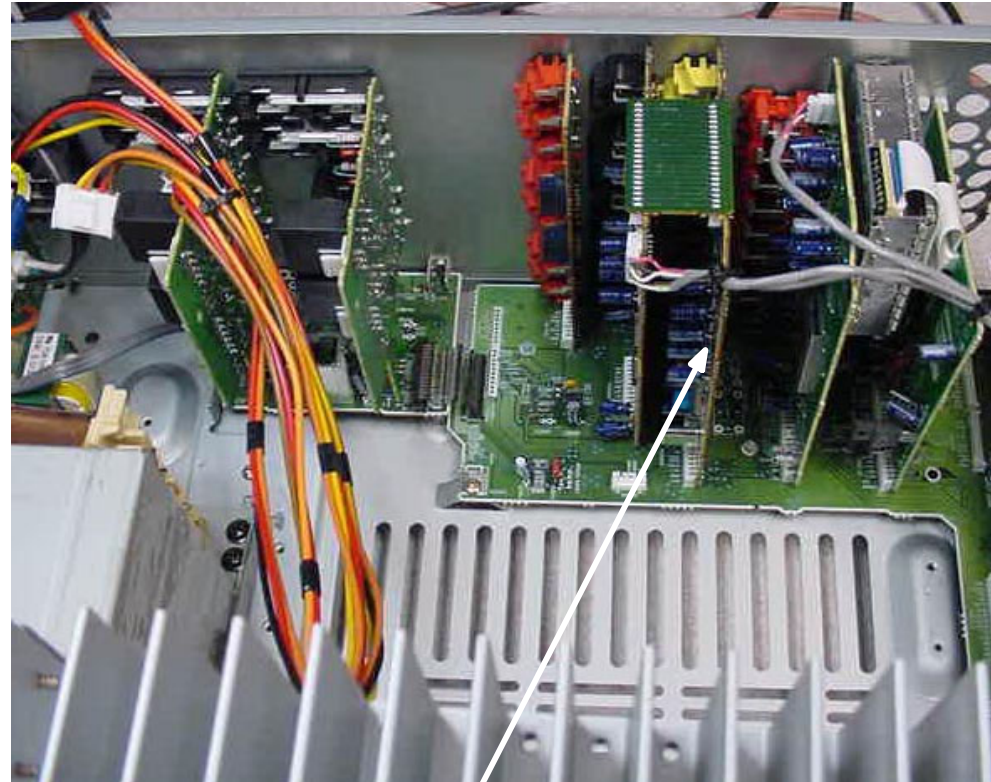
Secondary power connector from P6951 being disconnected. JL6953B and P6952A found to the right may be disconnected.

With the power amplifier set on its side, the input PCB assemblies are exposed for easy troubleshooting and repair. Individual PCB may be checked without the other. S-video may not work without the composite, but if the composite works the problem with S-video is simple to asses. Speaker relay is fully functional even though there is no audio passing through as main amp is disabled. For additional ease Tuner module and its support PCB may be removed.

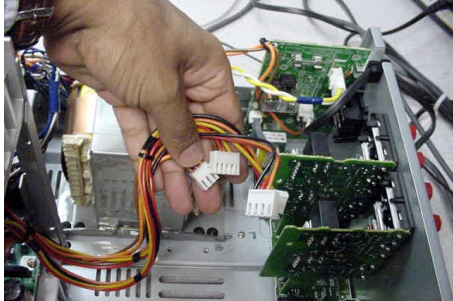
All four connectors from P6810, P6812, P6008A and P6008B are disconnected to give ease of movement for the power amplifier module.

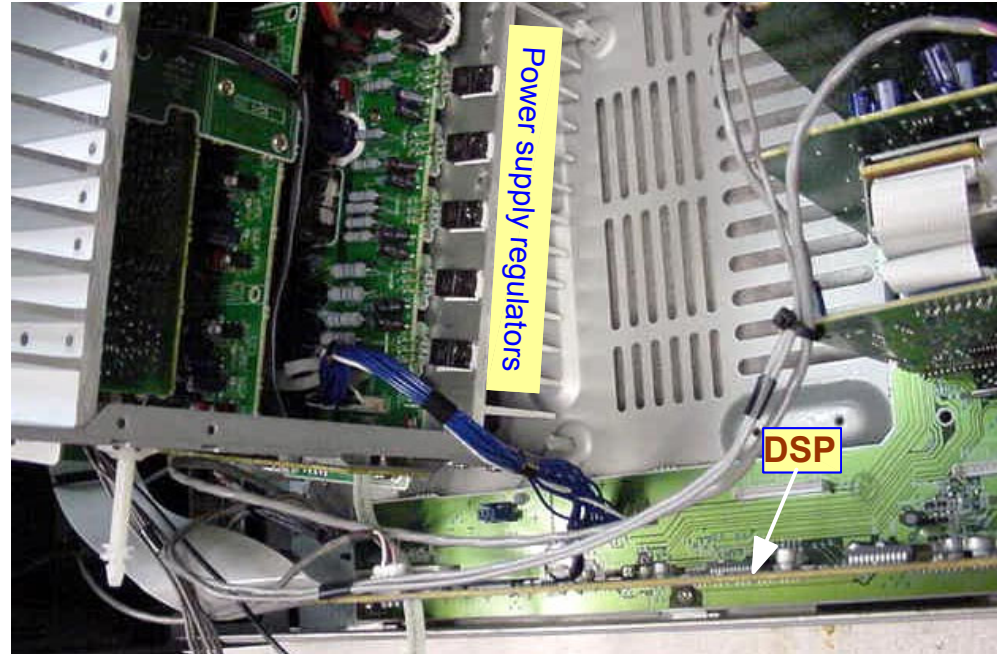
Amplifier assembly is then lifted from back to the front to stand in its side, The blue wire from P9502 is rerouted to insure amplifier movement is simplified. P9502 must be reconnected to make sure DSP and other PCB has the necessary operating voltages. At this point DSP is exposed for troubleshooting.

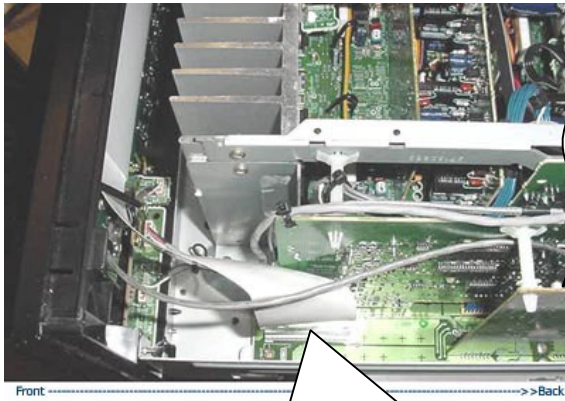
DSP PCB

P7701A connector ribbon wire also needs unplugged to accommodate the vertical pull of the Volume PCB located next to the DSP

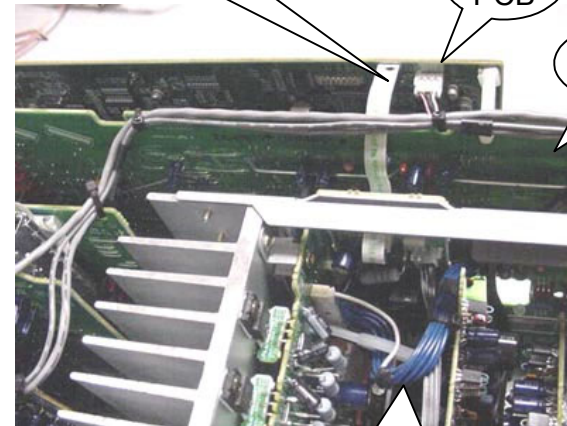
System control on front panel must remain connected via ribbon wire at P7201B

Blue connector ribbon wire from P9502 temporarily need be disconnected

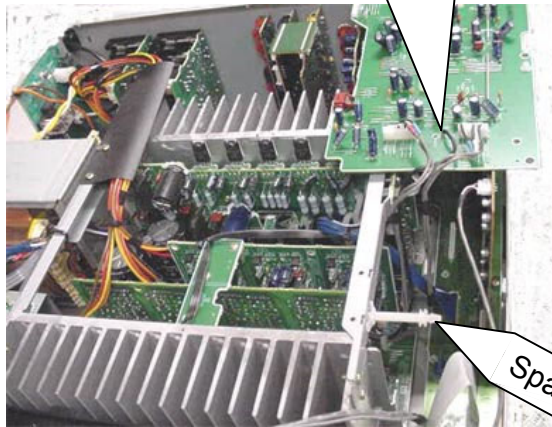
P5004E, P6101A and P5003E connector wires are seen still in place. These wire need unplugged and or desoldered to remove Volume PCB NCAF-7262.

Spacer Post

Wire from P9502

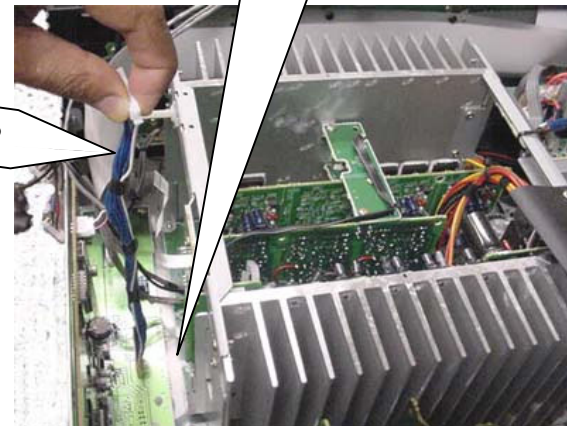
Figure shows volume control completely removed

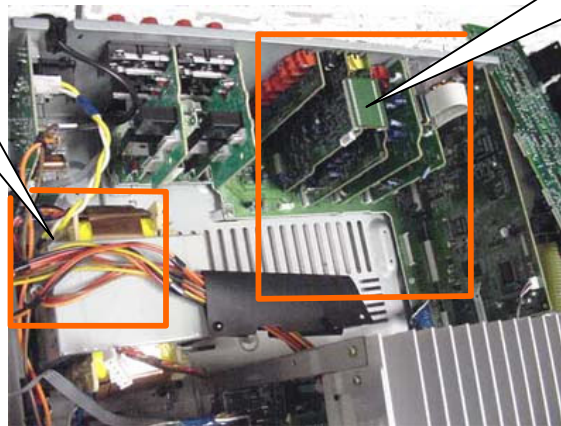
Power amplifier output signal wires to speaker terminal PCB connector terminals P6812E, P6008B, P6810D and P6008A are seen removed.

In this block area exist all inputs and output I/F PCBs. Since the main amplifier is standing on its side, All input and DSP PCBs are accessible for trouble shooting.
