ROTEL®

Technical Manual

DC/DC CONVERTER RV-C1

Serial No. Beginning
NB90517

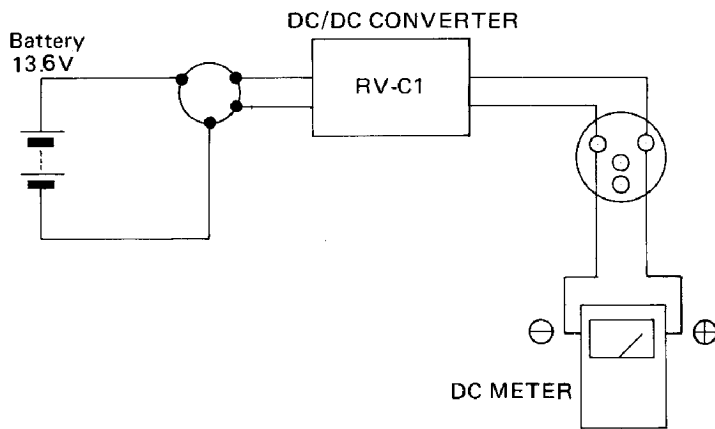
Adjustment of Output Voltage

1. Connect the 13.6-volt DC battery power source to the power input plug. The output terminals should be rendered to a non-load condition.
2. At this condition, adjust the Potentiometer VR901 so that the reading of the DC voltage meter connected to the output plug pins 4 (+) and 3 (-) indicates 44 volts.
