SERVICE TECHNICAL INFORMATION

ONE POINT REPAIR

UTSUNOMIYA, DEC. 20, 1998
 REF. NO.: SI-98-037
 CUSTOMER RELATIONS & SERVICE DIV.

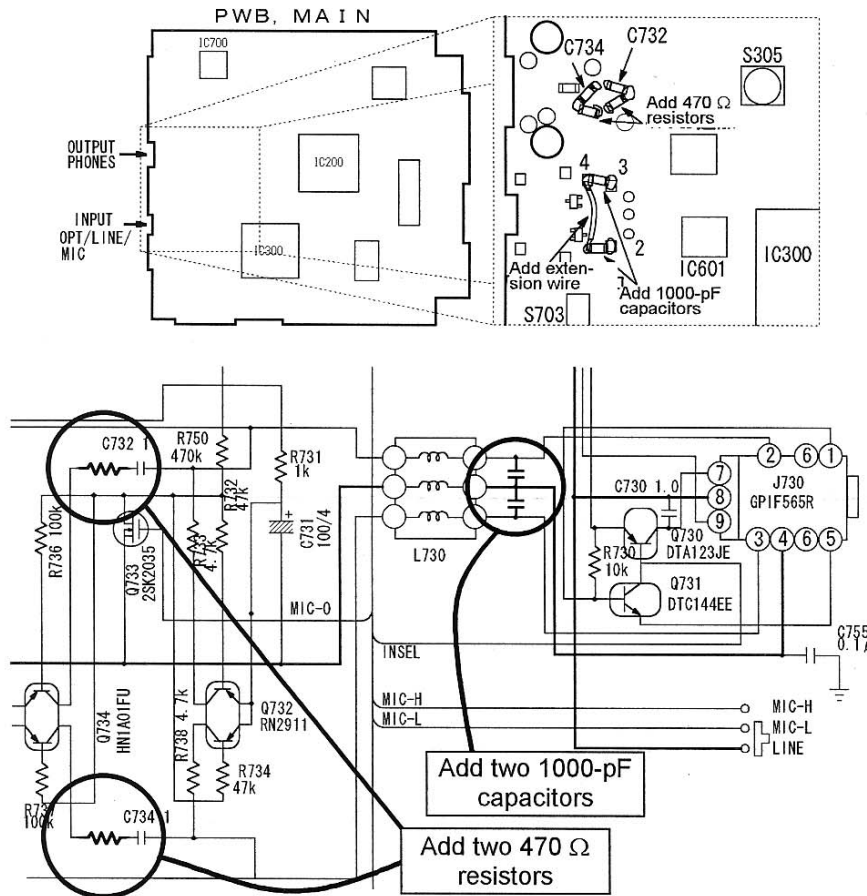
- MODEL : AM-F5 D, AEZ, AHE / F7 D, AH
 SUBJECT : Interference from FM radio wave on signals recorded using a microphone.
 CONTENTS : In strong electric field of FM radio wave, interference from the radio wave may occur in signals recorded using a microphone. Take the following actions against the symptom.
 Add two input-control resistors 470-Ω and two 1000-pF capacitors.
 Connect the resistors to the lands of C732 and C734, in series to C732 and C734.
 Apply the capacitors between pin2 - pin 4, and between pin3 - pin4 of L 730. Add an extension wire between pin2 - pin4.

Ref.	Part name	Part number	Remarks
	C-RES U 470	88-108-471-080	2-unit package
	C-CAP U 1000p	87-012-274-010	2-unit package
