Service Technical Information

MODEL NO.	AM-F70 / F65
SUBJECT	"Caution!" display appears.

REF.No. :G - 99 - 019 - E0

DATE :02. JUN. 1999

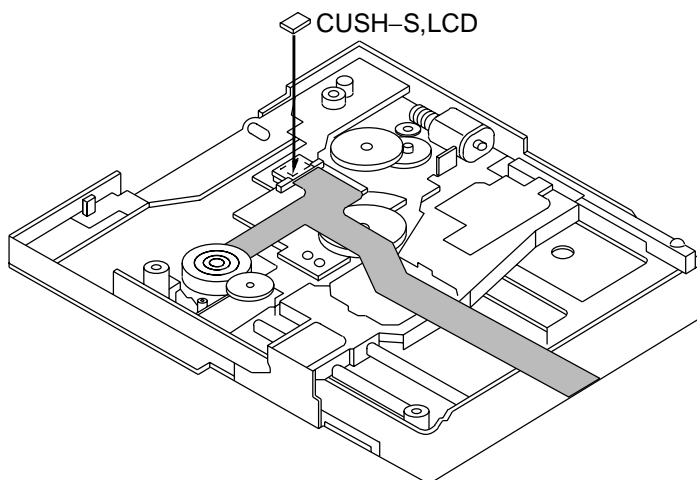
Fig. 1

The unit displays "Caution!" and does not operate.

This symptom occurs when μ -COM fails to detect on/off of OWH UP(S50)/DOWN(S51) SW.

- If on/off detect of a switch fails even though the OWH position detect switch is pressed:
Replace the detection switch with new one.
- If the lever runs on to OWH UP SW(S50) (See Fig.1):
Remove the lever away from the switch, and then affix a cushion (CUSH-S, LCD) on to the connector of PWB, MECH (CN50).

If that is the case, replace the two switches, S50 and S51 with new ones.
