## **SERVICE TECHNICAL INFORMATION**

## **ONE POINT REPAIR**

REF. NO.: SI-98-052

MODEL: AM-HX30 D, AEZ, AK, AHK, AHR

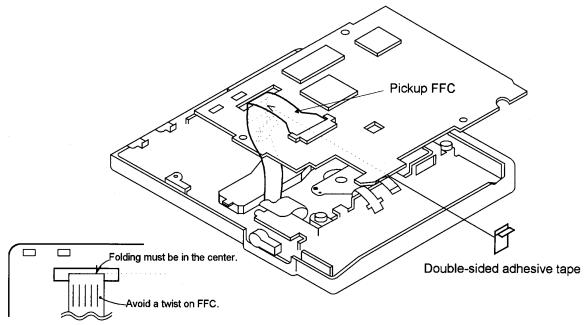
CONTENTS: Double-sided adhesive tape is used to place FFC from the pickup on the main C.B

of the listed models. If a C.B of the models is removed for repairing, place the pickup FFC again using a new piece of double-sided adhesive tape. Failure in correct handling of the pickup FFC may interfere with the movement of a pickup on innermost radius of the disk. It may cause error in reading TOC, indicating "DISC

ERROR."

Placing pickup FFC: Cut double-sided adhesive tape into a 7mm-by-5mm piece, and place it onto

the pickup FFC. Place the pickup FFC on the back side of C.B, avoiding a

twist.

\* Do not reuse a piece of removed adhesive tape again.
