## SERVICE TECHNICAL INFORMATION

### ONE POINT REPAIR

UTSUNOMIYA, AUGUST 30, 1997  
REF. NO.: SI-97-032  
CUSTOMER RELATIONS & SERVICE DIV.

MODELS : NSX-999mk2

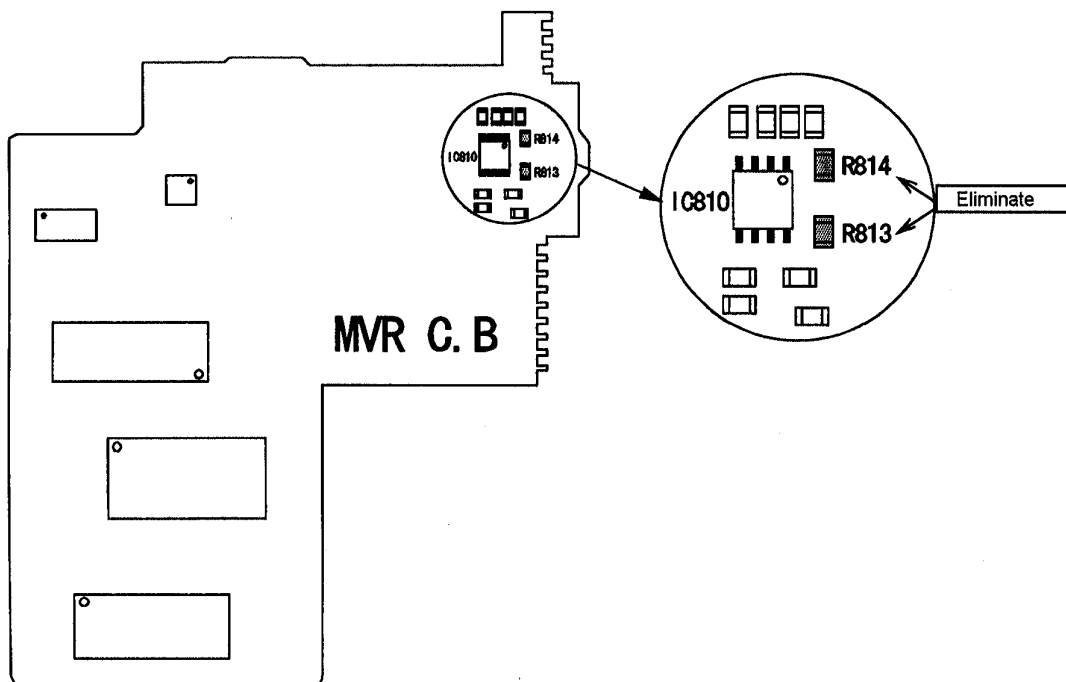
SYMPTOMS: With respect to the aforementioned model, when the VR is adjusted, noise such as commotion may be heard from the speaker. When it is indicated, take the following countermeasure.

Confirmation method : Turn the VR during the playback on the third song (17 Hz) of the test CD (TCD-782), the symptom can be confirmed comparatively easily.

REMEDIES : Eliminate the following resistors.

- 1) R813 and R814, 22 kilo ohm on the MVR C.B.
