Service bulletin # H/K2001-03 June 2001

Models: AVR110/210/310/510 (2000/3000/4000/5000)

Subject: No Output In Surround Mode

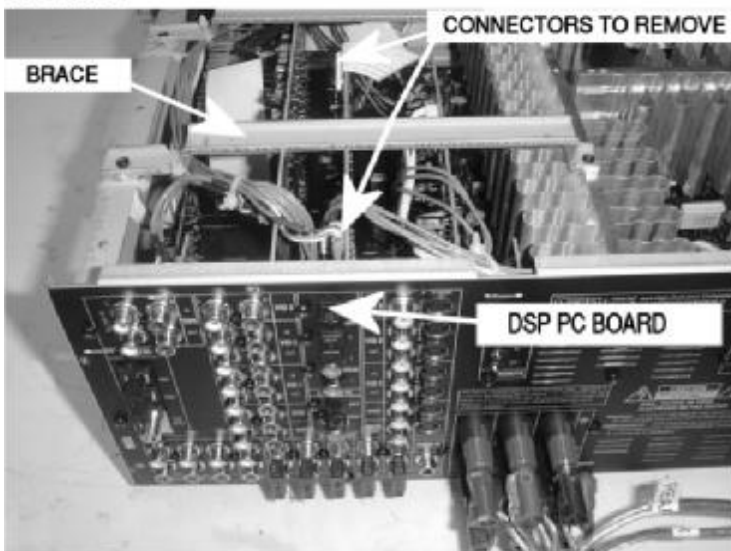
FIGURE 1

- 1) Remove the top cover, (14) Black Phillips screws at the sides and rear of the unit.
- 2) Locate the DSP PC Board; Figure 1. Remove the metal brace at the top of the unit.

- 3) Pull the white 21 conductor ribbon cable at the rear of the DSP PC Board straight out of its receptacle.
- 4) Unplug the multicolor 5 conductor moxex cable at the top of the DSP PC Board.

- 6) Pull on the left side of the rear backplate, away from the receiver chassis; you should be able to pull it away enough to allow the DSP PC Board to be pulled straight up and out of the receiver. If necessary, cut any additional cable ties that would prevent removal of the DSP board.

- 7) Replace IC4 (called IC04 in the parts list), with h/k part# J2131328001X. Caution: IC4 is an electrostatically sensitive device and can be damaged by careless handling; you must follow proper static control procedures to prevent damage to the IC.

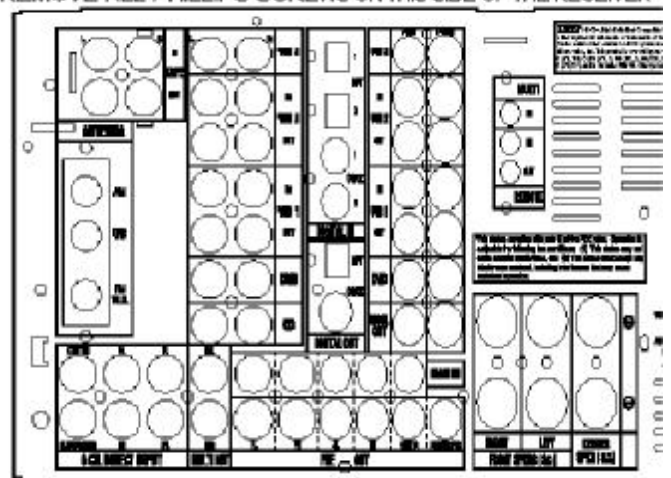
FIGURE 2

- 5) Remove the (33) black Phillips screws on the left side of the rear backplate; see Figure 2. Do not remove any additional screws on the right side. Remove all three black plastic plugs that cover the optical inputs at the rear of the DSP PC Board.

REMOVE ALL PHILLIPS SCREWS ON THIS SIDE OF THE RECEIVER
