ST-4 CIRCUIT DIAGRAM

ST-4

Service Bulletin # 1

LAMP VOLTAGE ADJUSTMENT

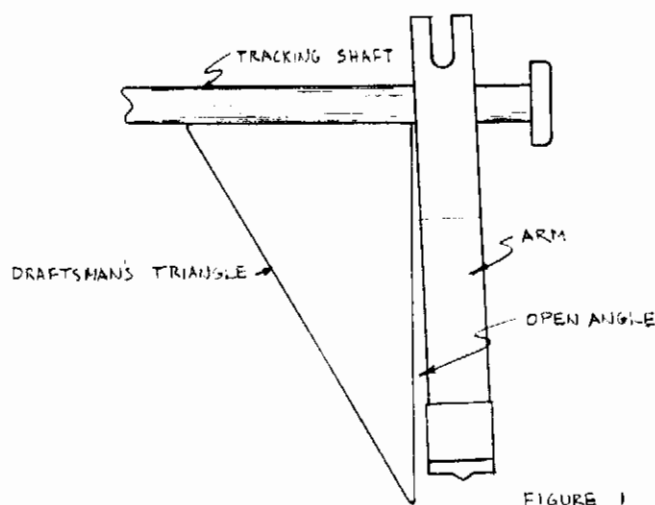
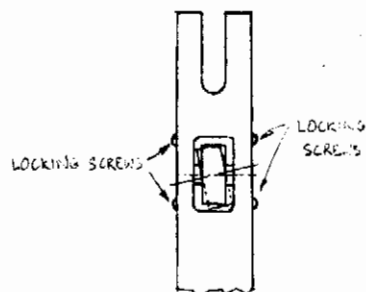
- Step 1. Check tracking angle. Lower arm to record surface near outer edge of record and permit the unit to run for two or three minutes.
- Step 2. Now gently stall the turntable platter, taking care not to cause the stylus to jump grooves. With the platter still, lay a draftsman's plastic triangle on the record surface with one edge against the tracking shaft. (See Figure 1) Use the other edge to sight along the arm.

- Step 3. If the angle is open as shown in Figure 1, the axis of the tracking roller must be rotated counterclockwise as viewed from above. (See Figure 2) If the angle is closed, the roller must be rotated clockwise. To do this, loosen the two upper screws on one side of the tone arm. Either side can be used, but be sure to loosen the two screws on the same side.

If the cartridge moves to the left, as the arm descends, this is an indication that the left rear nylon foot is not protruding enough. Loosen the left rear lower screw and pull the foot down slightly. (See Figure 3) 1/64" will be the maximum adjustment needed. Now re-tighten the screw, taking care not to strip the threads in the nylon. If the arm still moves to the left, more adjustment is needed.

If the angle is open as shown in Figure 1, then the right front nylon foot will have to be adjusted down slightly. To do this, loosen the right front lower screw and pull the foot out a small amount. The movement should be no more than $1/64$ of an inch. Tighten the screw, taking care not to strip the threads and check the angle again. When the arm is straight (90° to the tracking shaft) in the up position, and if the tracking angle is correct, very little side movement should occur when the arm raises.

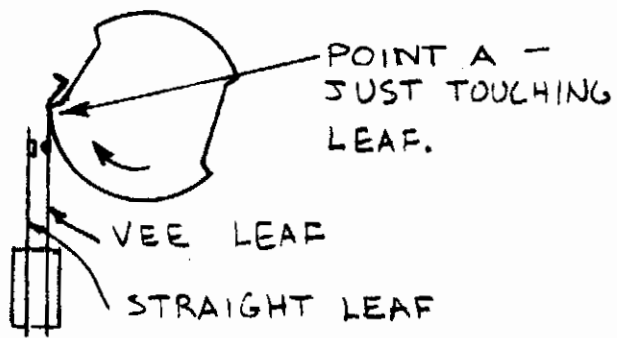
FIGURE 1

- STEP #1 Remove the bottom of the unit.
- STEP #2 Tip the unit up on it's right side, with the notched nylon cam facing up as shown in Figure #1.
- STEP #3 With the power off, rotate the cam clockwise by hand and observe the leaf switch contacts. With the "Vee" actuator of the switch in the notch as shown in Figure #1, the "Vee" leaf should be adjusted so that it is just touching the cam surface at point A as shown in Figure #1. There should be very little deflection of the leaf at this point, but it should be touching the cam. With small needle nose pliers, bend the leaf to the proper position.

- STEP #4 Now check the clearance between the switch contacts, with the switch open as shown in Figure #1. Clearance should be between .015 inches and .030 inches. Bend the straight leaf of the switch to obtain this clearance.

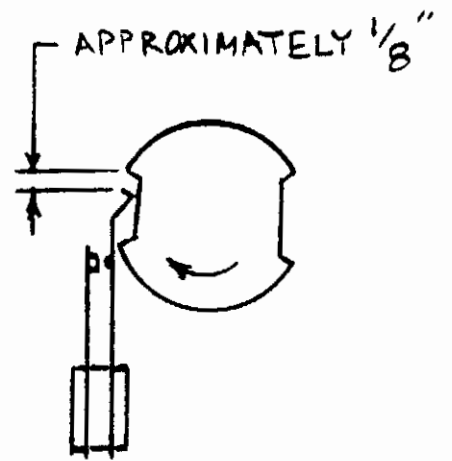
FIGURE 2

- STEP #6 With the unit still in the tipped up position, plug the power cord in, taking care to avoid all open wiring inside the unit. Now, reach around to the normal top surface of the unit and depress the cueing button. This will take more force than normal since, in the tipped up position, the suspension springs are pushing hard against the deck. Observe the amount of coast of the cam after the switch drops into the notch. It should stop quite abruptly, approximately 1/8 of an inch, into the notch as shown in Figure #2. Cycle the cueing mechanism several times to make sure the switch is operating properly.

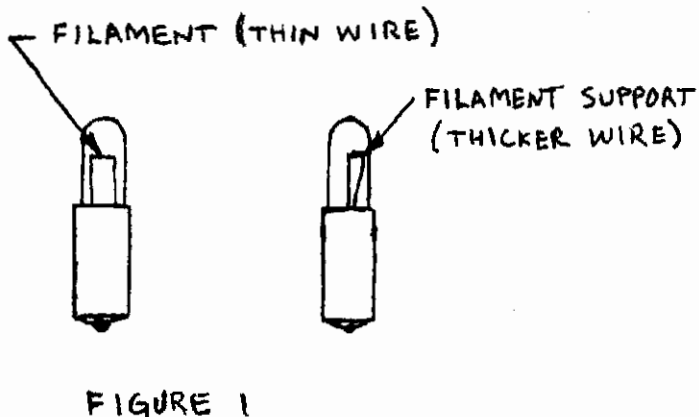
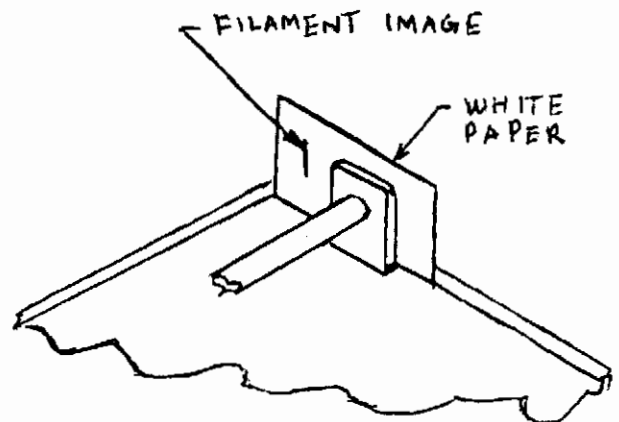
- Step 1. Install lamp. Use only a GE #1829. The bulb filament is in the shape of an inverted "U" with filament supports on one side. (See Figure 1) When installing the bulb place the filament supports towards the rear of the unit. Note that the socket can be twisted as described in Step 3, to obtain this position.
- Step 2. With the unit on, place a piece of white paper or cardboard at the right side of the unit just behind the tracking shaft bearing block. (See Figure 2)
- Step 3. Now twist the socket, and observe the filament image projected on the white paper. Twist the socket until the two vertical legs of the "U" become a single vertical line. In most cases this will not be a perfect single line, nor will the image be perfectly vertical. Check to be sure that the filament supports are towards the rear of the unit.

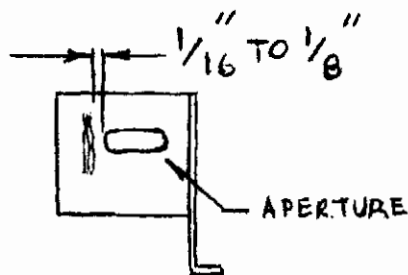
FIGURE 1

- Step 1. Remove the mirror cover located on the left rear of the arm.
- Step 2. Remove the motor housing cover.
- Step 3. Using a record with a narrow run-off groove, (3/8") cue the tone arm down at a point within 1/4" of the end of the recorded music.
- Step 4. As the arm tracks close to the finish of the record, observe the lamp filament image on the photocell housing. (See Figure #1)

Just as the music ends, the filament image should be between 1/16" and 1/8" from the front of the photocell aperture as shown in Figure #1.

- Step 5. If the image is too far from the aperture bend the mirror closer to the tone arm as shown in Figure #2. The mirror is fastened to a soft aluminum bracket, and it bends easily.

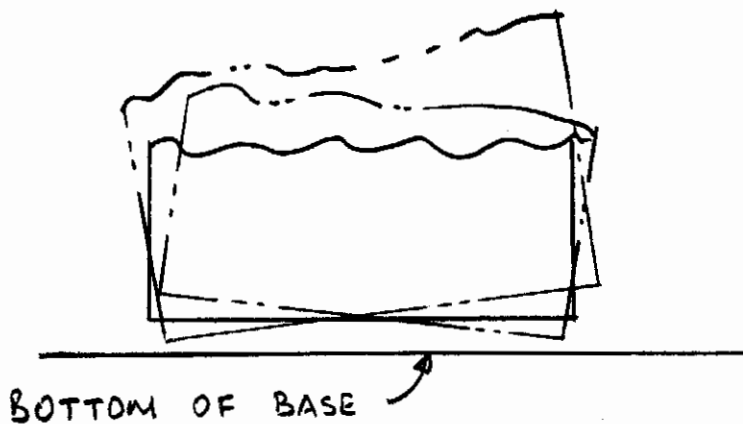
FIGURE 1

- STEP #1 Remove the bottom of the turntable base.
- STEP #2 Note that there are 3 screws holding the drive motor bracket to the side of the wooden base. (See Figure #1)
- STEP #3 Loosen all 3 screws to a point where the bracket will move. Leave the lower center screw slightly snug so that when the bracket is moved it will stay in place.
- STEP #4 Now tip the bracket either to the right or left as required. If the bracket is tipped to the right, the belt will ride lower on the drive pulley. If the bracket is tipped to the left, the belt will ride higher on the pulley. (See Figure #1) The belt should normally ride just clear of the flanges as shown in Figure #2.
- STEP #5 When the proper belt position has been obtained, tighten the 3 bracket screws taking care not to strip the threads in the wooden base.
- STEP #6 Replace the bottom of the unit.

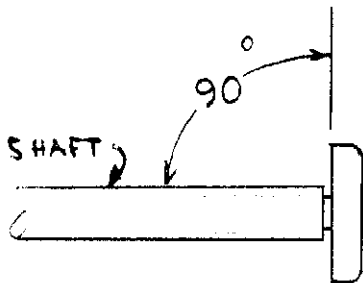
FIGURE 1
(TOP VIEW)

- STEP #4 Now from underneath the deck, loosen the 4 screws holding the bearing blocks and move the bearing blocks apart. Tighten the screws and check for proper end play. Take care to be sure the bearing blocks are square with the shaft as shown in Figure #1.

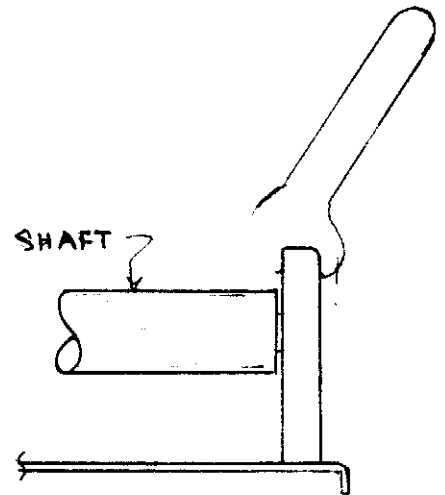
FIGURE 2
SIDE VIEW

- STEP #5 If end play is still insufficient, it is possible that the deck is warped. Place a small adjustable wrench on the right bearing block as shown in Figure #2 and bend outwards.

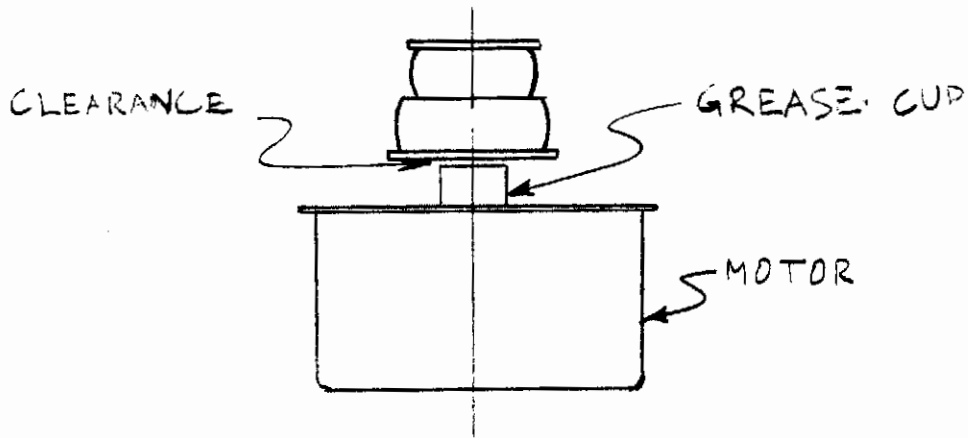
From Serial #4788 up, a grease filled bearing cup was added to the platter drive motor as shown in Figure number 1. The cup is filled with a special lubricant.

For units under that number, if desired, the cup can be added by carefully removing the pulley and pushing the cup into place. Wipe off excess grease and push the pulley back in place. Filled cups will be supplied by RABCO.

NOTE: There must be clearance between the bottom of the pulley and the top of the cup. Allow between ".010 and ".030. A piece of paper folded several times or thin cardboard will suffice as a shim.
