CD PLAYER

DP-29

SERVICE MANUAL

(MIDI M-29/M-49)

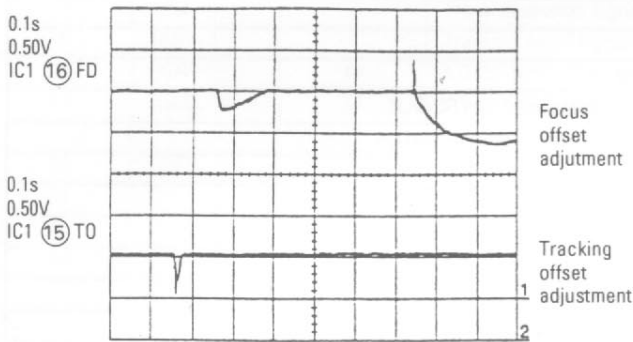
Fig.1

1. Focus offset (Fig.1)
2. Tracking offset (Fig.2)
3. E/F balance (Tracking error balance) (Fig.3)
4. RF level AGC function (HF level : constant)
5. RF level automatic follow-up of the tracking gain

This automatic adjustment is performed each time a disc is changed. Therefore, each disc is played back using the optimal settings.

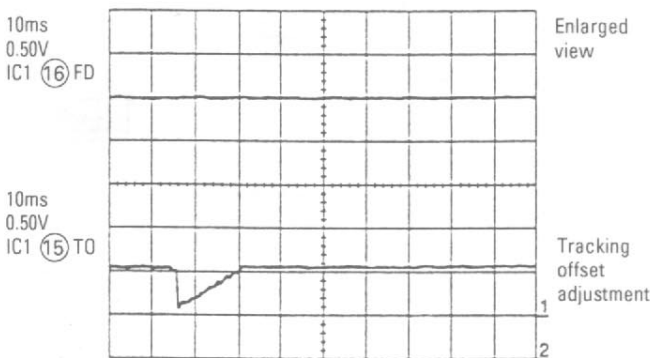
Fig.2

Does the output waveform of IC1 (16) (FD) match that shown in Fig.2?

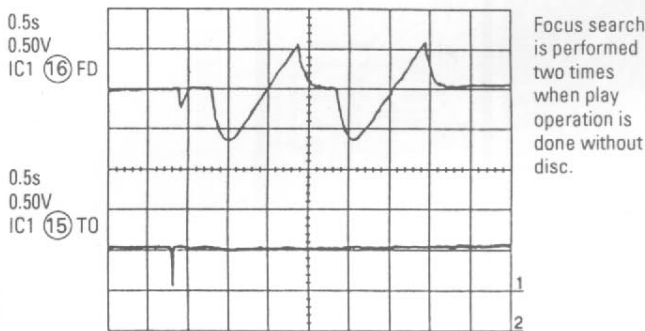
Fig.5

• Playback can only be performed when a disc is loaded.

Is the Focus servo active? (Can you hear it working?)

Does the DRF signal change from "L" to "H"?

Is HF waveform normal (See the Fig.6,7)?

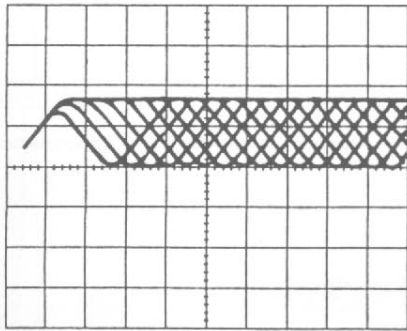
Fig.6

HF
 0.1V/DIV
 0.5 μ sec/DIV(DC)
 (When playing
 back the disc)

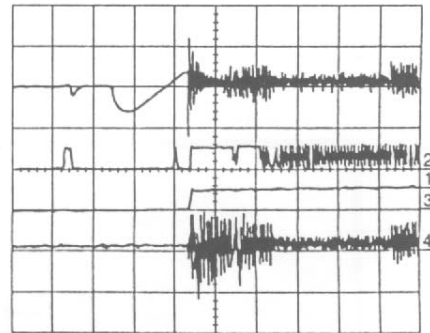
Fig.7

0.5s
 1.00V
 IC1 (16) FD
 0.5s
 10.0V
 IC2 (13) CLV+
 0.5s
 10.0V
 IC1 (54) DRF
 0.5s
 2.00V
 IC1 (7) TE

Waveform in
 case of normal
 playback

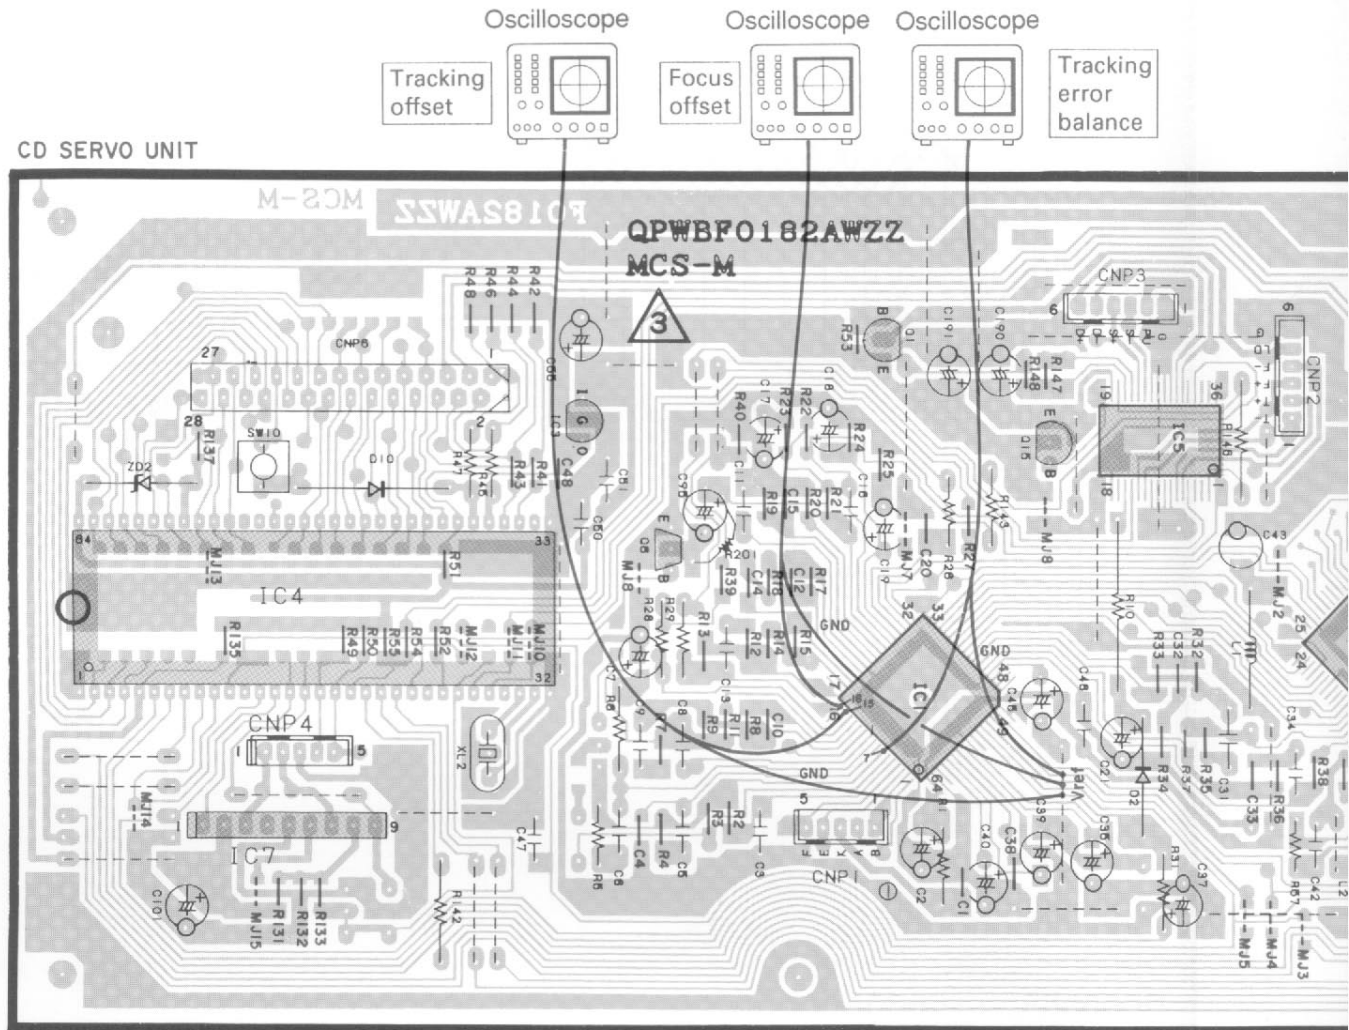
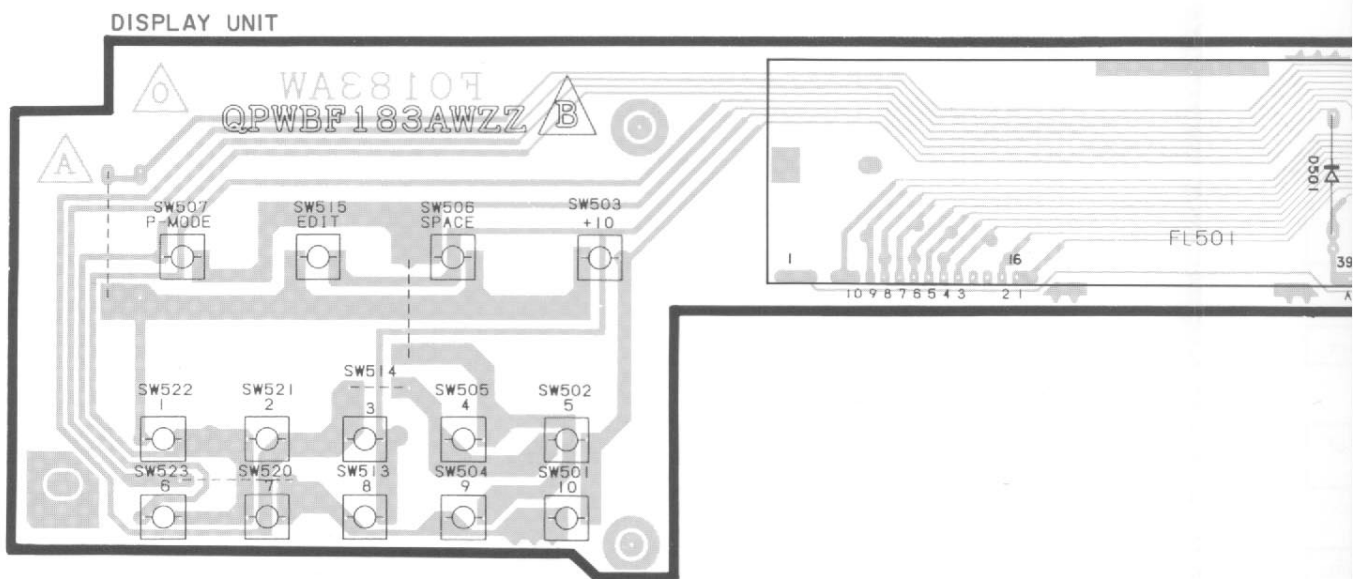
PC BOARD (COMPONENT SIDE VIEW)

CAUTION : On CD player, if connect the test measurements to Vref terminal, it is not connected to other test measurements.

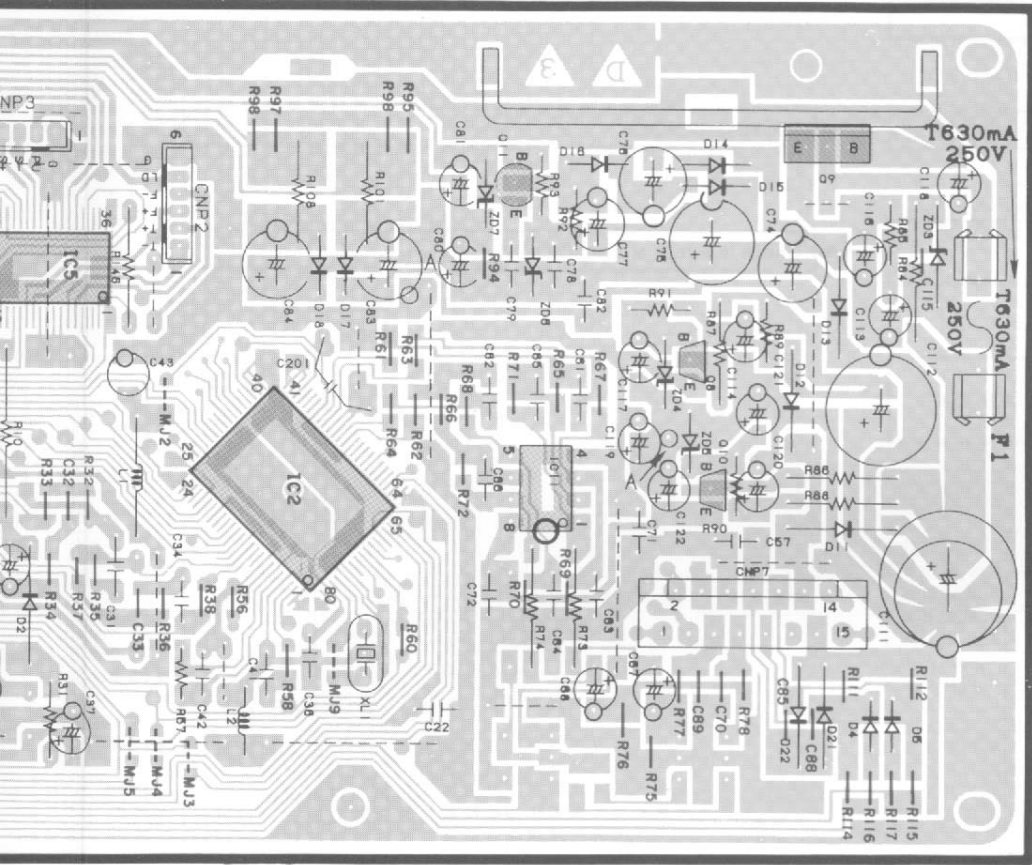
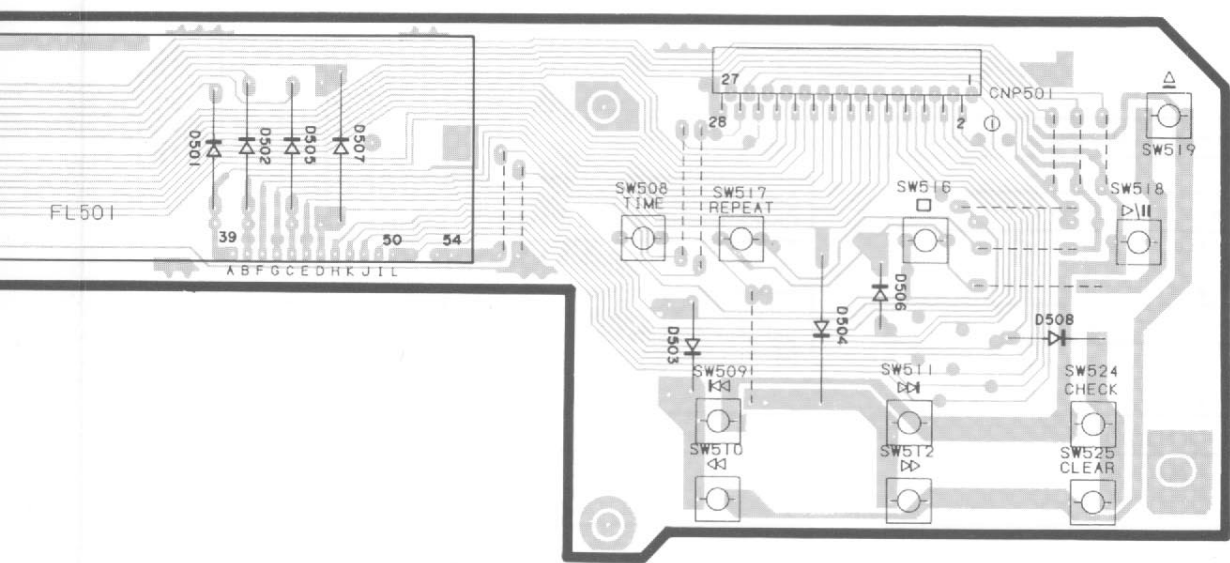
CD SERVO UNIT (PCB1)

Refer to the schematic diagram for the values of resistors and capacitors.

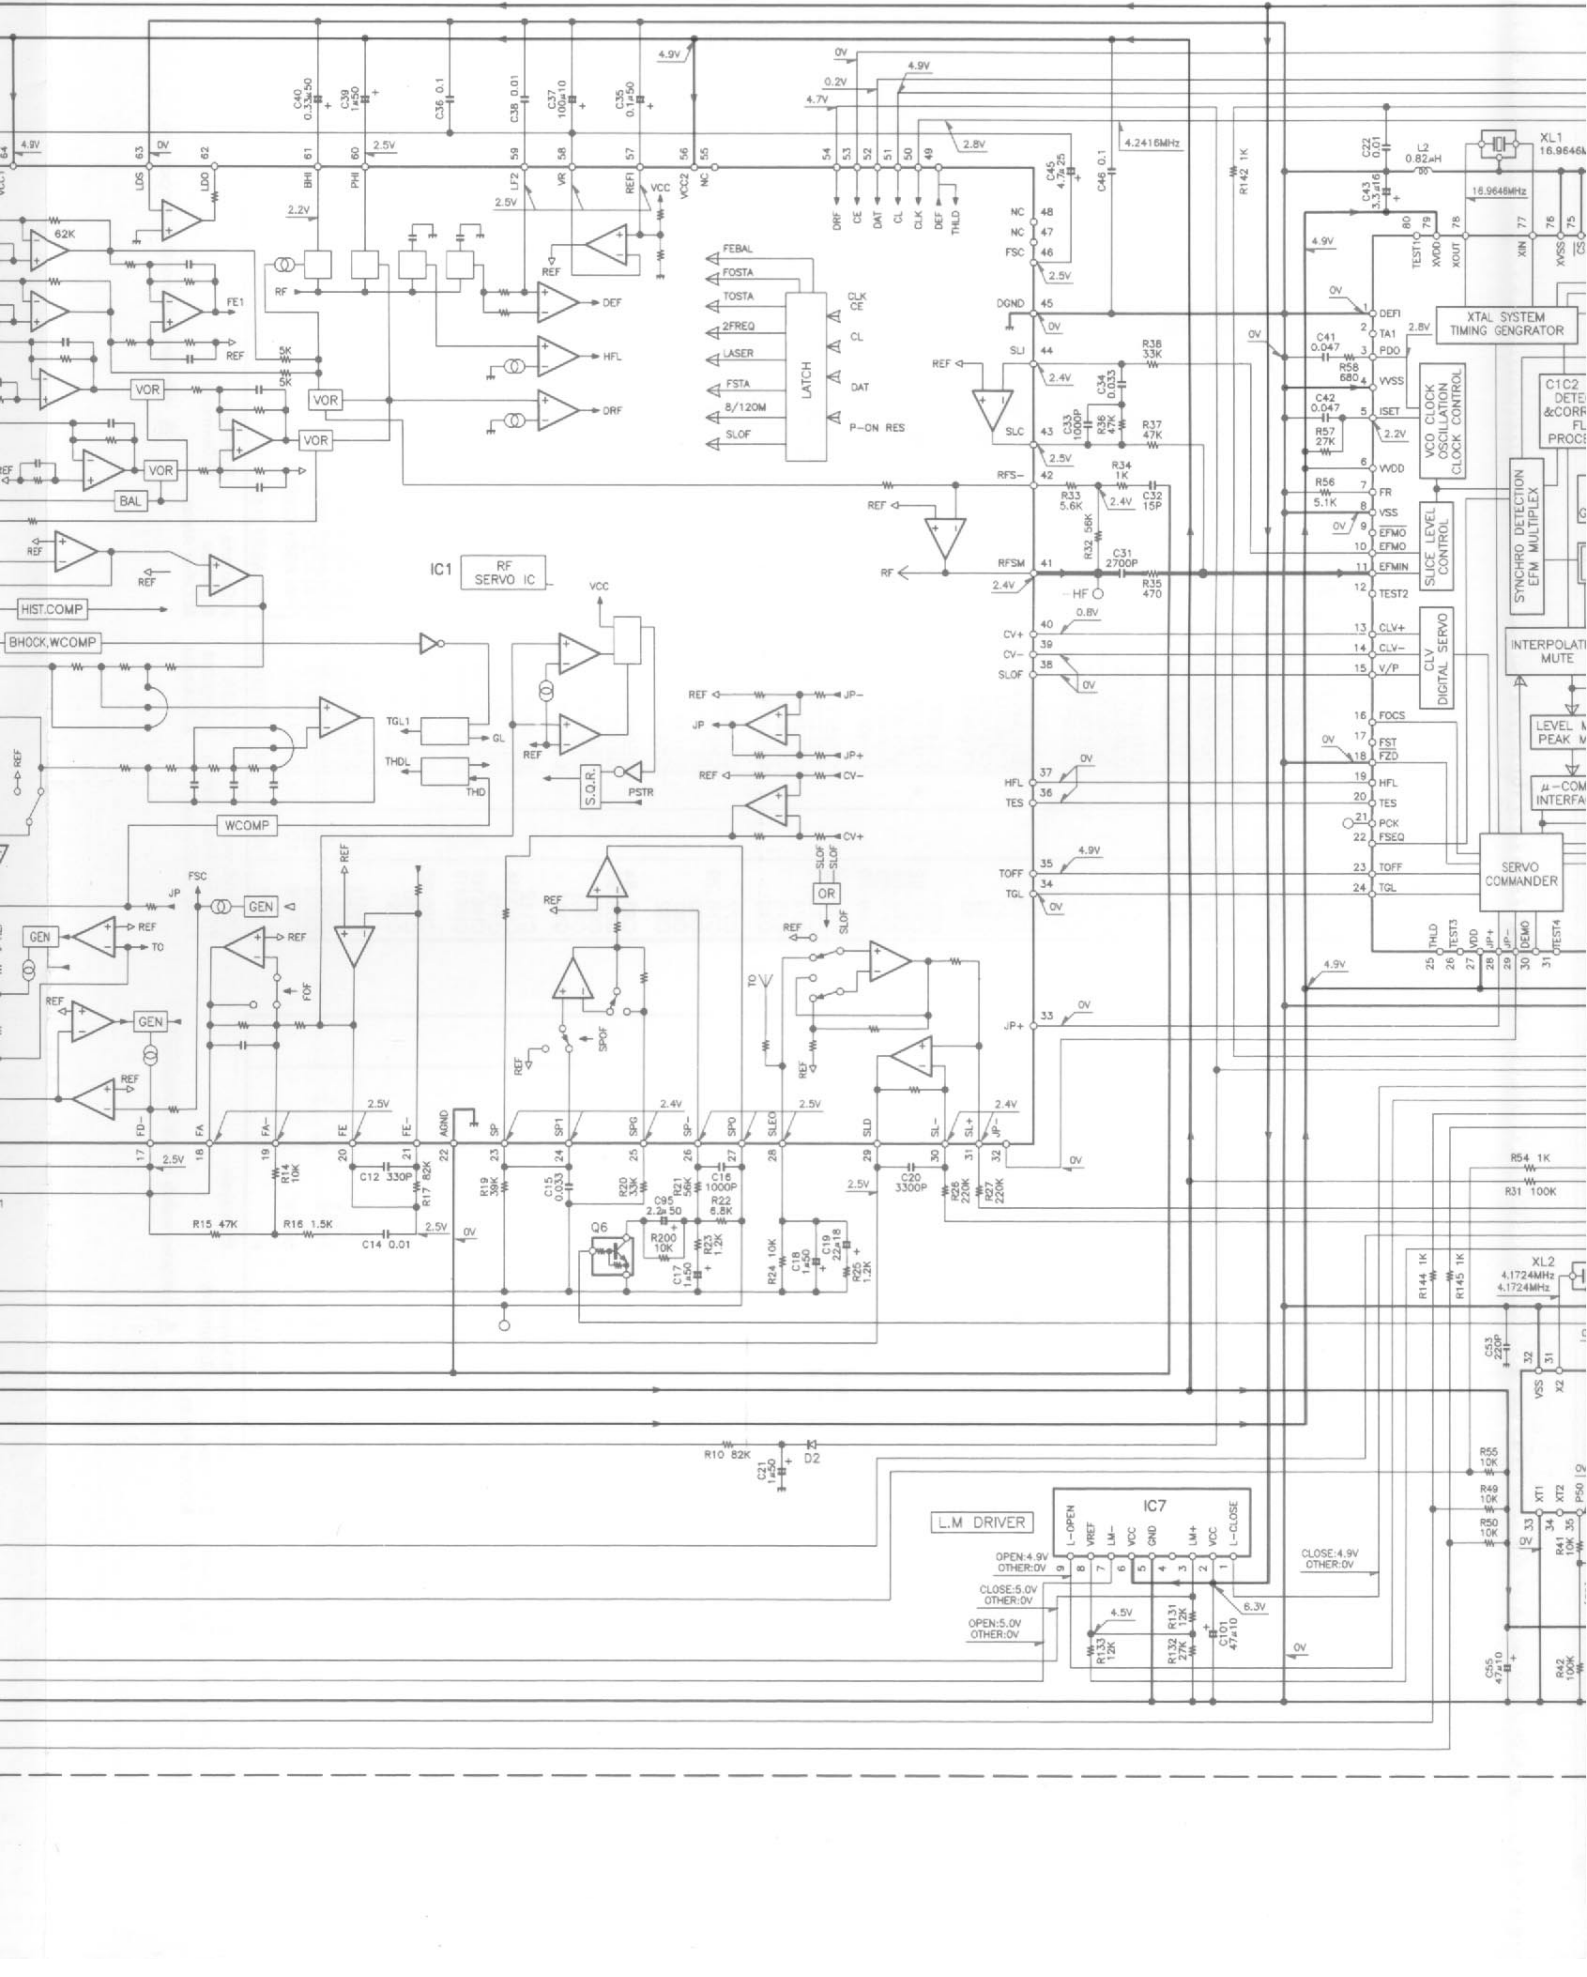
IC1 RF SERVO IC

L.M DRIVER

XTAL SYSTEM TIMING GENERATOR

VCO CLOCK OSCILLATION CONTROL

SLICE LEVEL CONTROL

DIGITAL SERVO

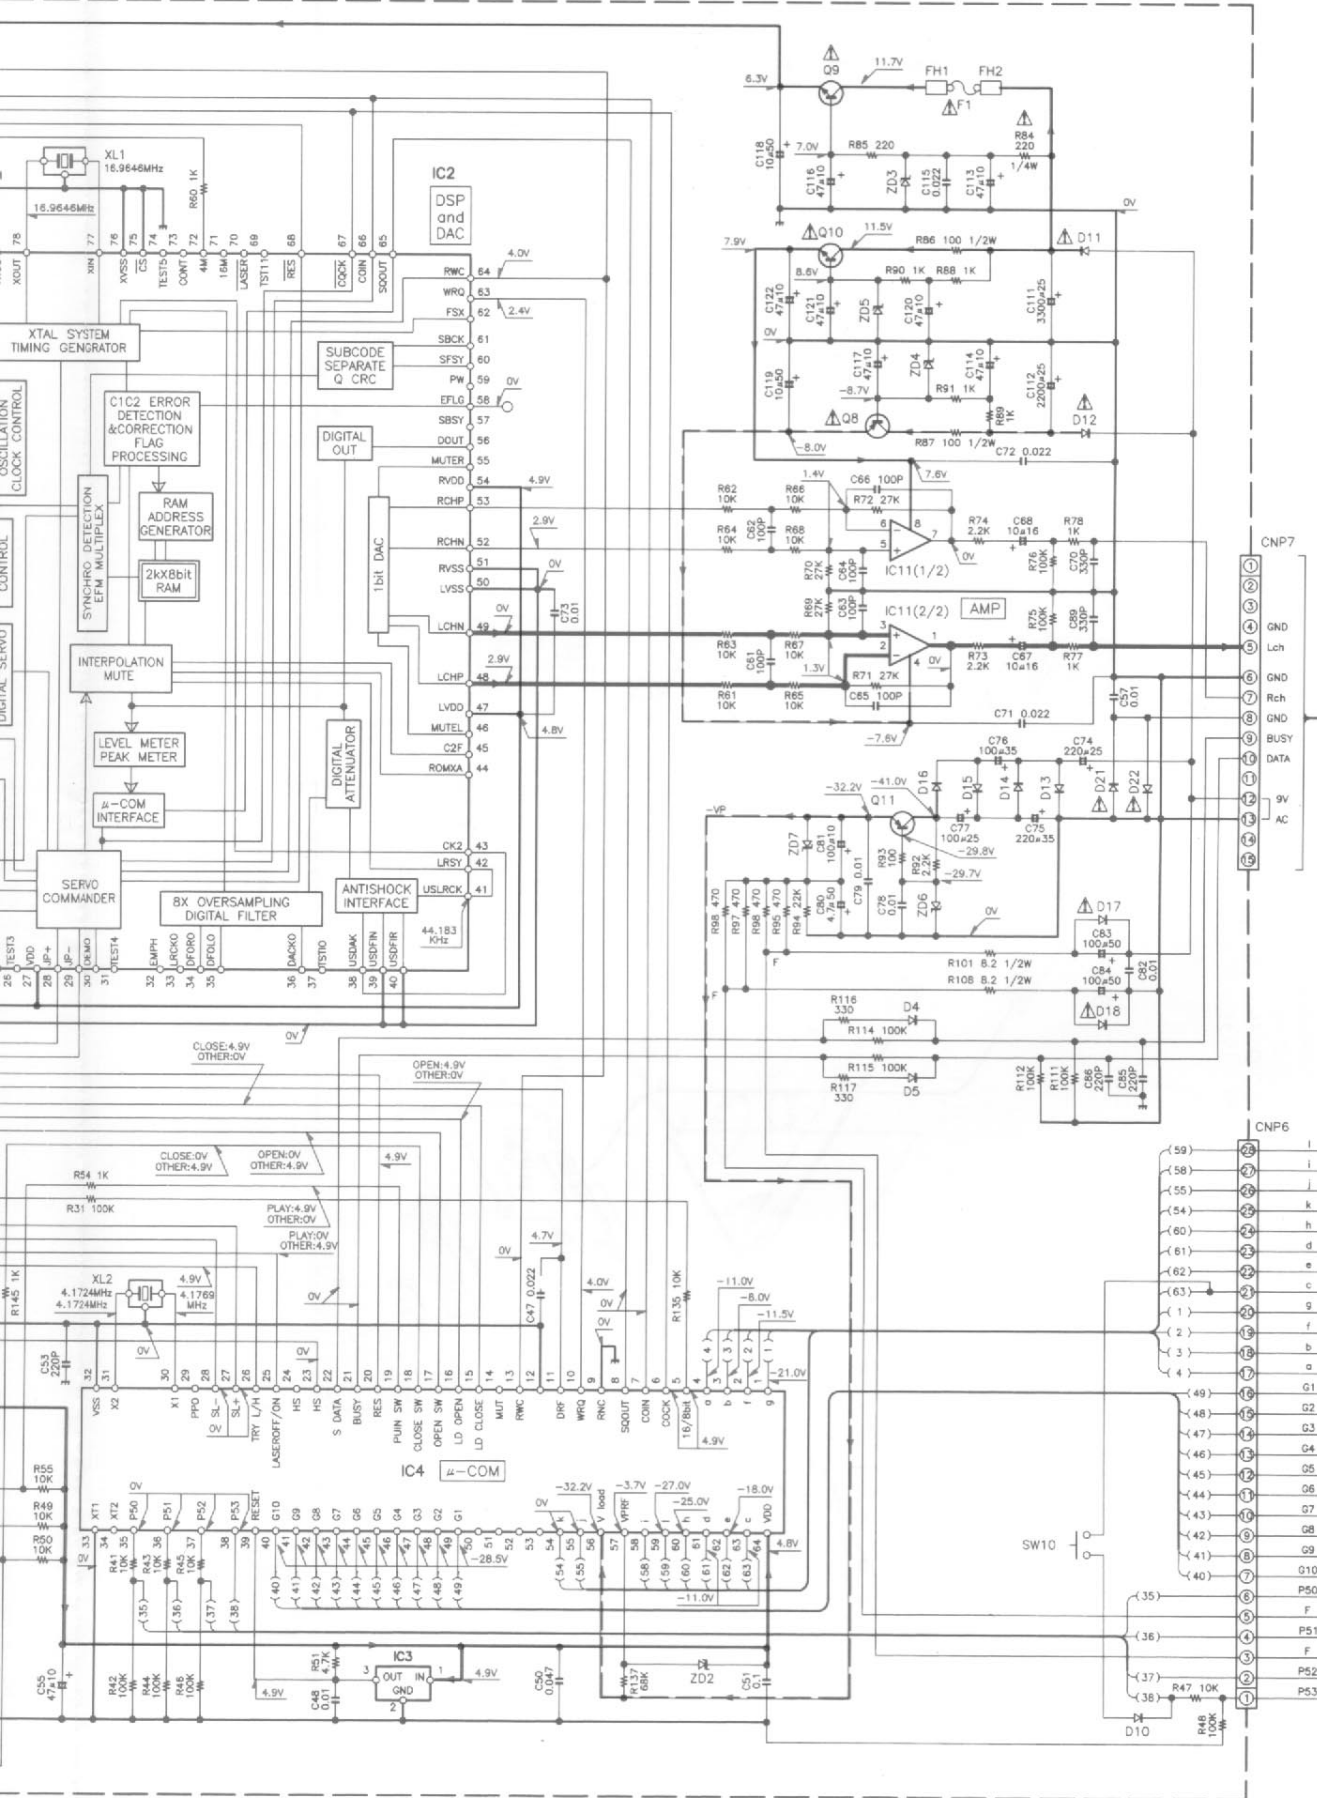
- IC1 : LA9233M
 - IC2 : LC78620E
 - IC3 : KIA7036
 - IC4 : IX0068
 - IC5 : M56748FP
 - IC7 : TA7291S
 - IC11 : NJM4580D
-
- Q1,8 : KTA1266GR
 - Q6 : KRC107M
 - Q9 : 2SD2012
 - Q10 : KTC3199GR
 - Q11 : 2SB1237R3
 - Q15 : 2SB562C
-
- Z2,4,5 : MTZJ9.1A
 - Z3 : MTZJ7.5B
 - Z6 : MTZJ33B
 - Z07 : MTZJ6.8B or R06.8J5(B2)
-
- D2,4,5,10 : ISS133
 - D11-13 : RL104

- The DC voltage is an actual reading measured with a high impedance type voltmeter. The measurement value may vary depending on the measuring instruments used or on the product. Refer to the voltage during PLAY unless otherwise specified; The value shown in () is the voltage measured at the moment of STOP.

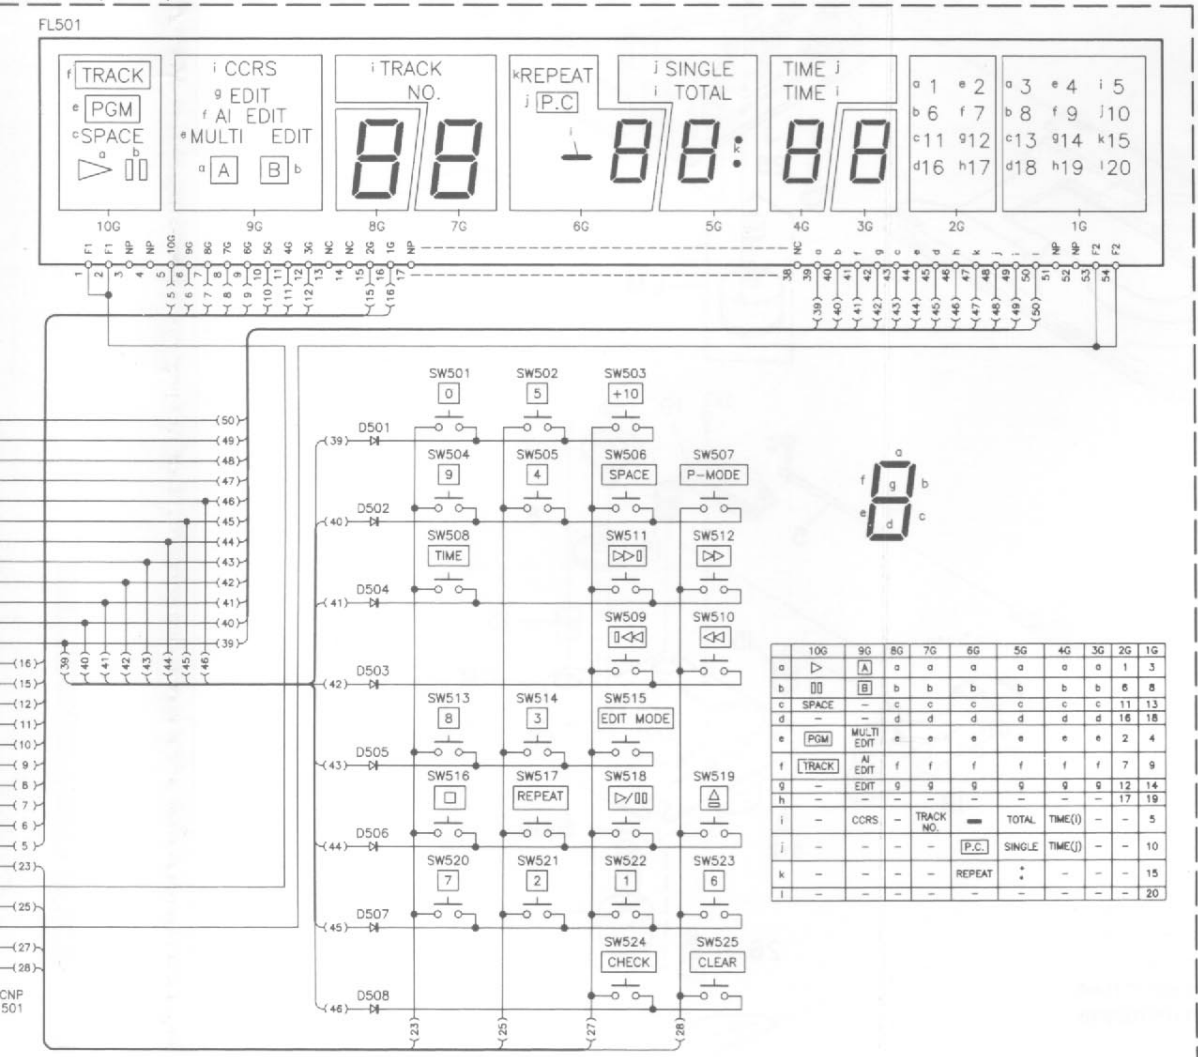
DISPLAY UNIT (PWB501)

D501~508 : 1SS133
FL501 : WK10BT6

10G	9G	8G	7G	6G	5G	4G	3G	2G	1G
a	>	[A]	a	a	a	a	a	a	a	1 3
b	[]	[B]	b	b	b	b	b	b	b	6 8
c	SPACE	-	c	c	c	c	c	c	c	11 13
d	-	-	d	d	d	d	d	d	d	16 18
e	[PGM]	MULTI EDIT	e	e	e	e	e	e	e	2 4
f	[TRACK]	AI EDIT	f	f	f	f	f	f	f	7 9
g	-	EDIT	g	g	g	g	g	g	g	12 14
h	-	-	-	-	-	-	-	-	-	17 19
i	-	CCRS	-	TRACK NO.	-	TOTAL	TIME()	-	-	5
j	-	-	-	[P.C.]	SINGLE	TIME()	-	-	-	10
k	-	-	-	-	REPEAT	*	-	-	-	15
l	-	-	-	-	-	-	-	-	-	20

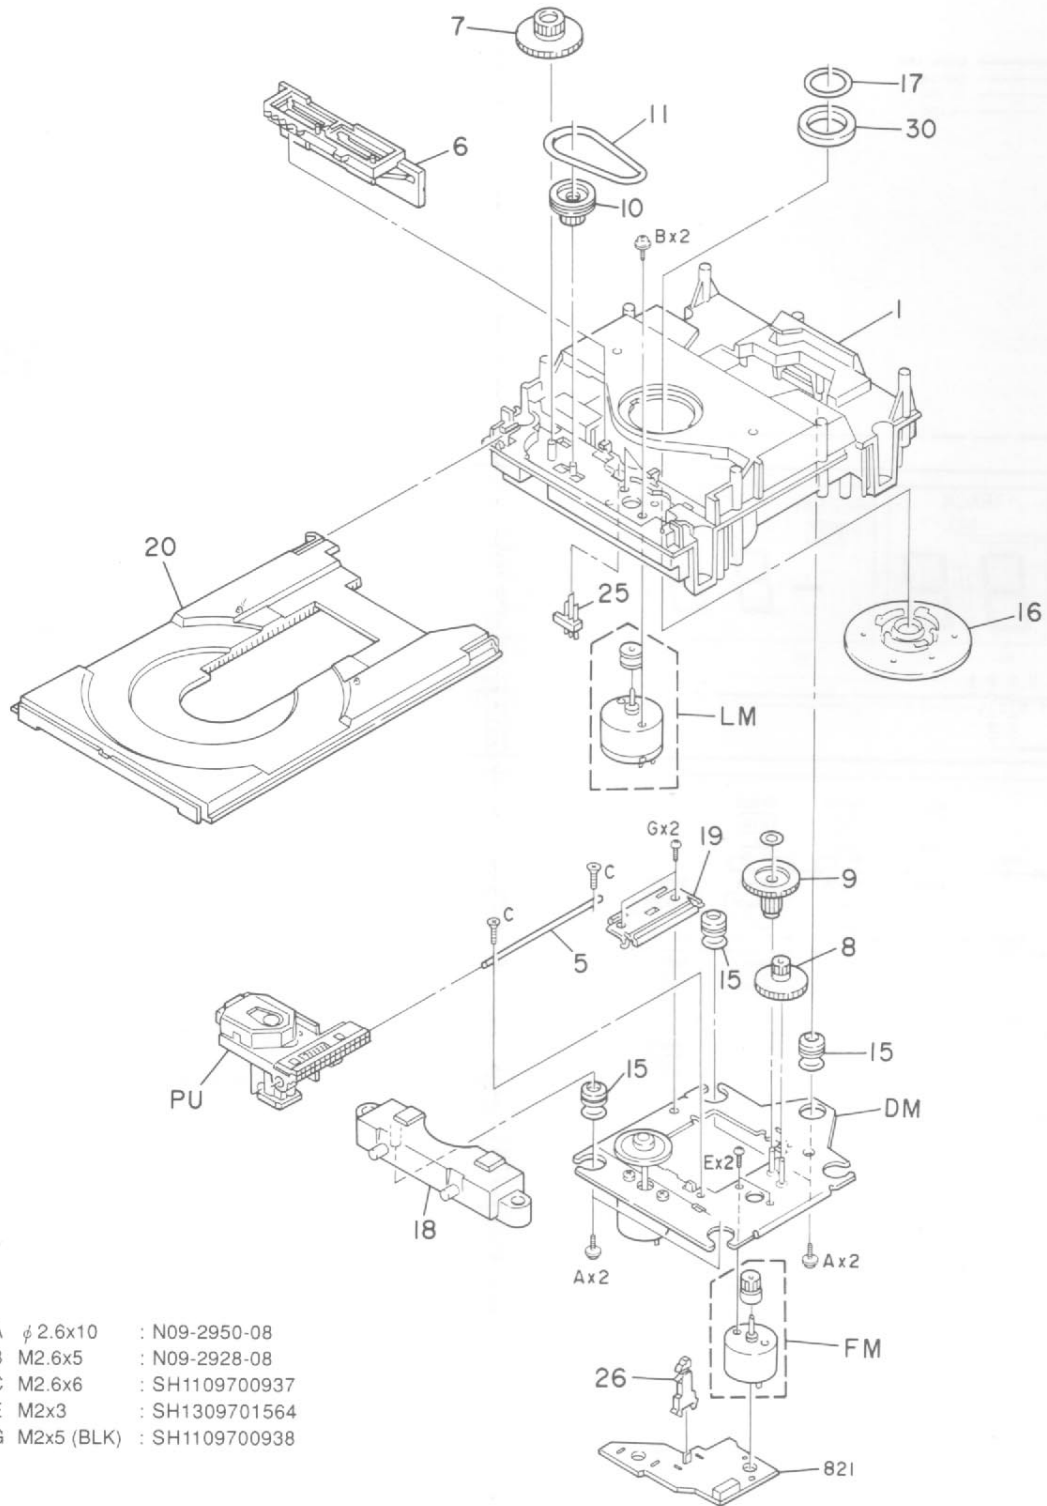
EXPLODED VIEW (MECHANISM)

- A ϕ 2.6x10 : N09-2950-08
- B M2.6x5 : N09-2928-08
- C M2.6x6 : SH1109700937
- E M2x3 : SH1309701564
- G M2x5 (BLK) : SH1109700938

Parts with the exploded numbers larger than 700 are not supplied.

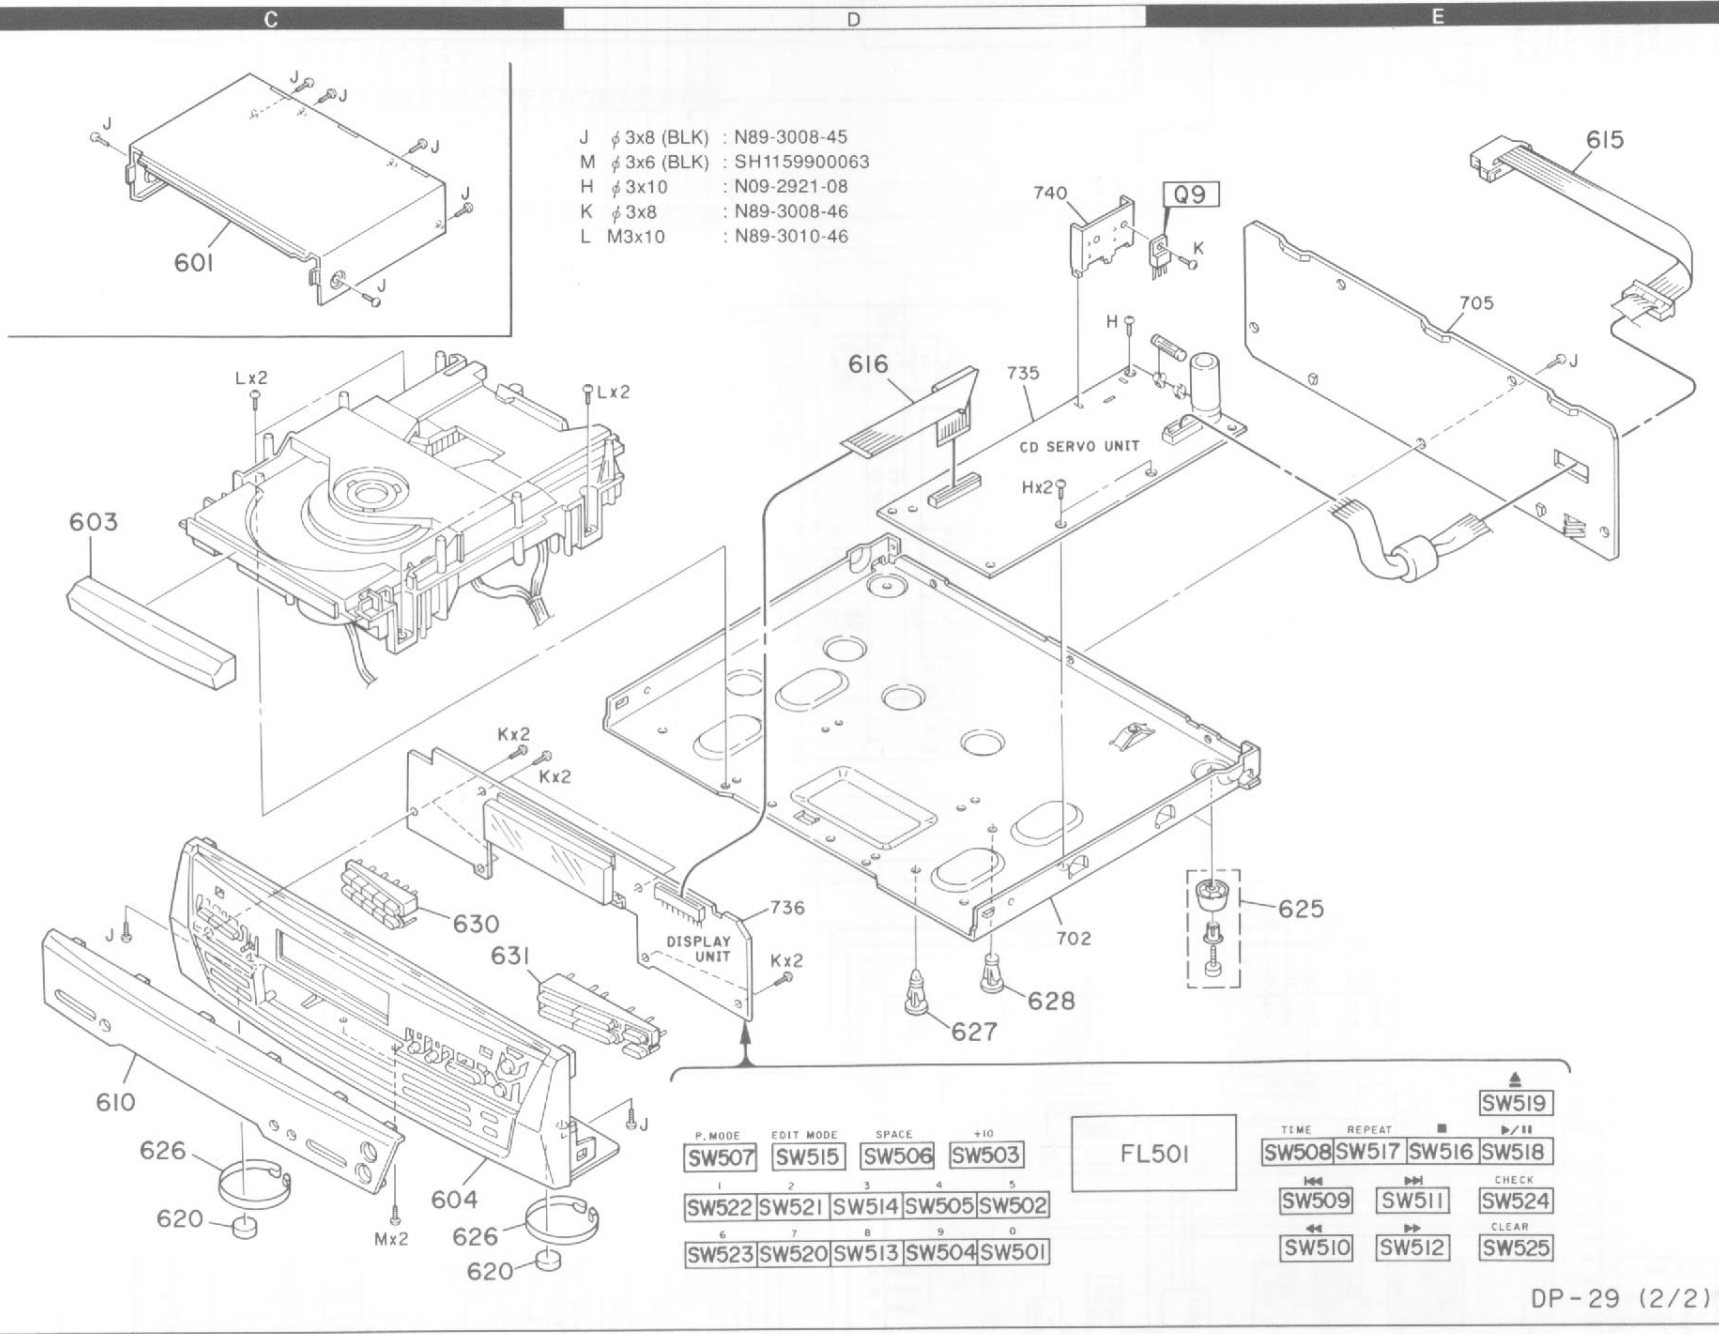
EXPLODED VIEW (UNIT)

Parts with the exploded numbers larger than 700 are not supplied.

- J ϕ 3x8 (BLK) : N89-3008-45
- M ϕ 3x6 (BLK) : SH1159900063
- H ϕ 3x10 : N09-2921-08
- K ϕ 3x8 : N89-3008-46
- L M3x10 : N89-3010-46
