# Technical Service Bulletin No. 27

Created by: Lab.gruppen AB Service Department

Reference no: C12

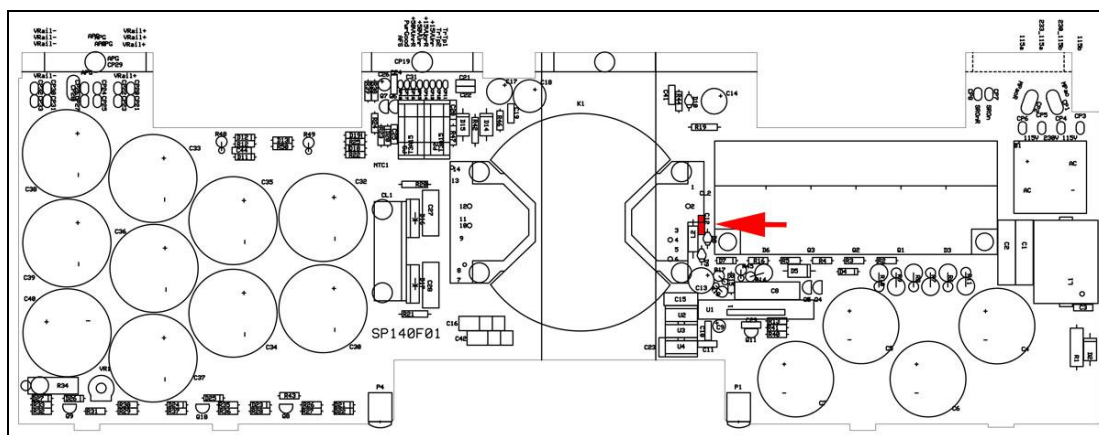
Screaming sound from power supply if amplifier powers up.

Amplifier does not power up.

Replace capacitor C12 with either of below listed components.
