## **Service Bulletin**

**No. :** MZ03-058

**Model:** CC4300, PMD371

**Subject:** DIGITAL Output (OPTICAL) jack was changed.

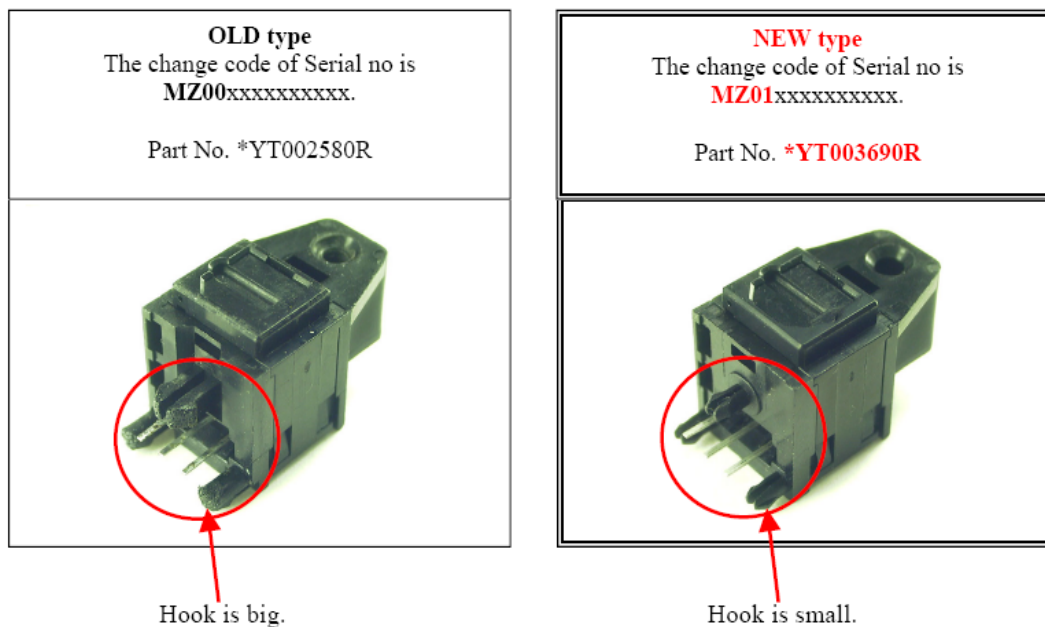
**Symptom:** The OPTICAL jack was changed by manufacturer.

**Solution:** 1) The OLD and NEW type are compatible in performance, but you cannot replace the OLD type with NEW type. (The PCB mounting hole dimension is different.)

2) The NEW type can be replaced with the OLD type.

Ref #	FORMER		NEW	
	Description	Part Number	Description	Part Number
NA	Digital Optical Jack	*YT002580R	Digital Optical Jack	*YT003690R
