marantz® SERVICE BULLETIN		Date: 8-Nov-2004	Model: SA8260, SA17S1
		Page: 1 / 2	REF.NBR: MZ04-080
Level		Application:	
★ ★		See below	
		Int.ref:

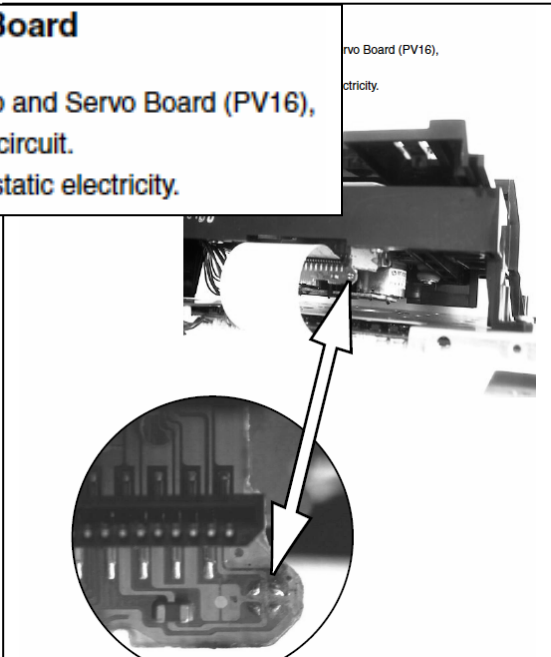
<p>4. CAUTION Optical pick up and Servo Board</p> <p>When removing the flat wire between Optical pick up and Servo Board (PV16), Solder the four lands pointed by arrows to short the circuit. Otherwise the LASER DIODE may be damaged by static electricity.</p>

1. CHIP RESISTOR (**330 OHM**) is added to Laser pickup PCB.

Please see the Service manual page 4

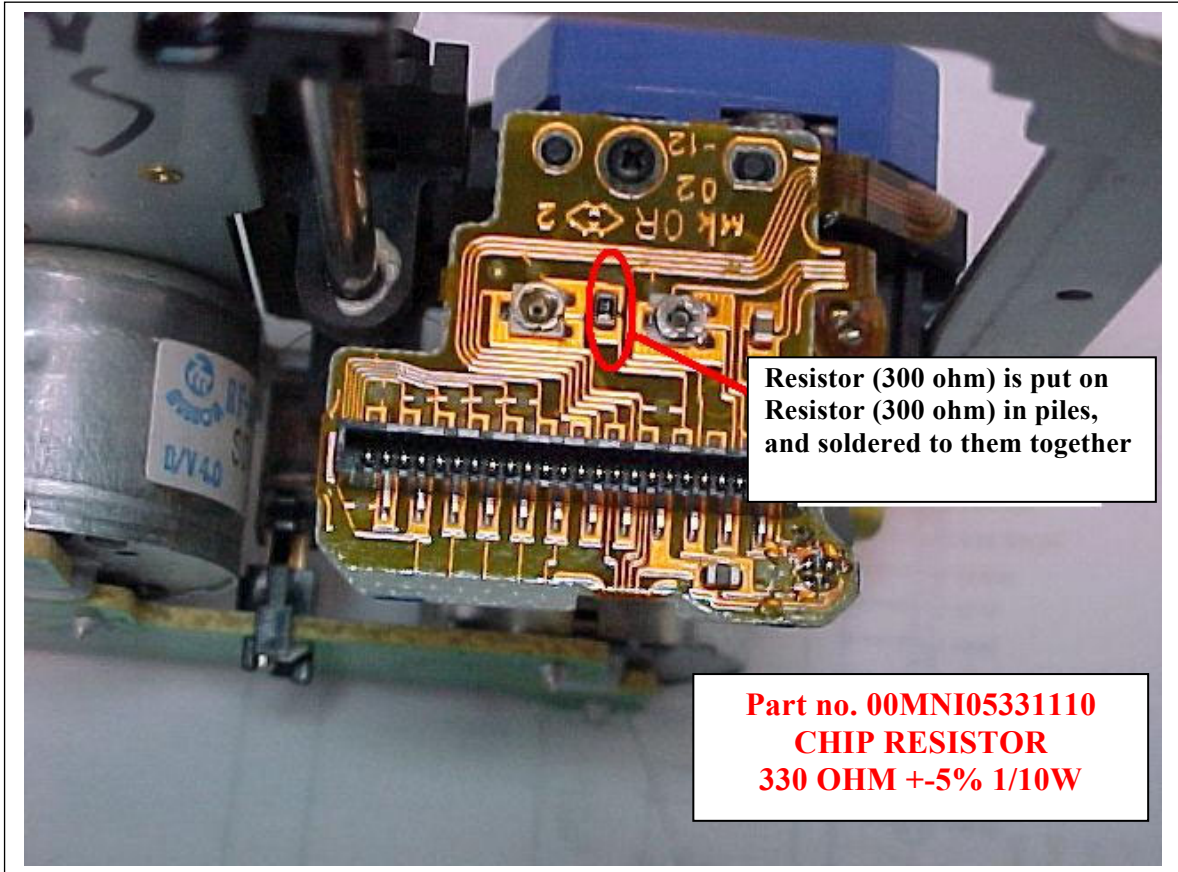
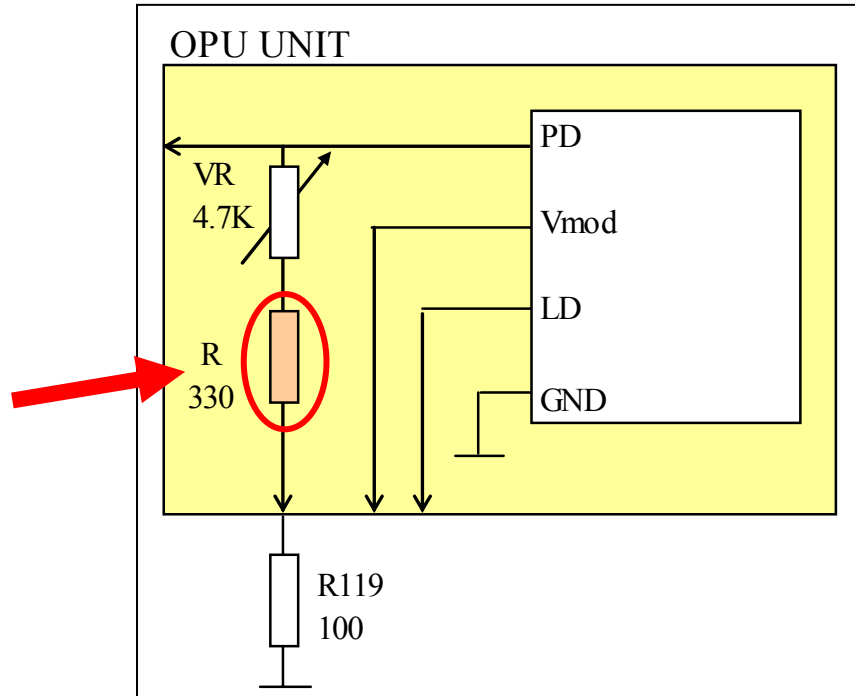
1. Can not playback Super Audio CD (low reflection DISC), "ERROR" is indicated on the display of the Unit.
2. Can not read TOC of low reflection DISC. The unit stops during playback Super Audio CD.

In order to keep HF level, about 2mA to 5mA of laser current is increased.

00MNI05331110 (CHIP RESISTOR 330 OHM +5% 1/10W)
