Service Bulletin

No.: MZ08-075

Model: SR5003, SR6003

Subject: INPUT PWB changed to delete soldered wires on the PWB. (The PWB changed for the improvement of product quality.)

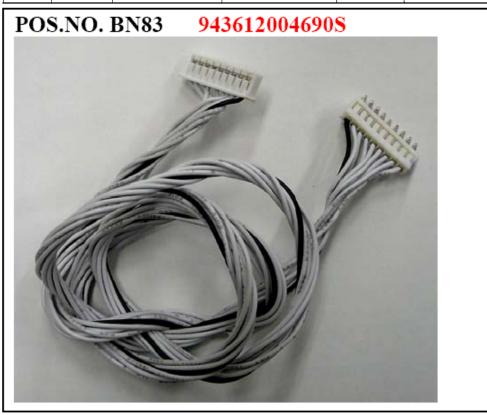
Connector CN83 of INPUT PWB

POS.NO. BN83 Cord with Connector

Part no. 943612004690S

This connector is soldered to Front PWB.

FRONT PWB POS.NO. CN83 Connector replacement procedure:

Connect this Cord to CN83 INPUT PWB.

CN83 (Connector) is removed and BN83 (Cord with Connector) is soldered to Front PWB.
