marantz® SERVICE BULLETIN		Date: 28-Aug-2004	Model: SR5400, SR6400
		Page: 1 / 2	REF.NBR: MZ04-061
Level		Application:	
★ ★		MZ00xxxxxxxxxx	
		Int.ref:	
		Subject: 1. Noise from Surround L/R Speaker. 2. The Sound is MUTE by operation of HDD Recorder. 3. The output level changes.

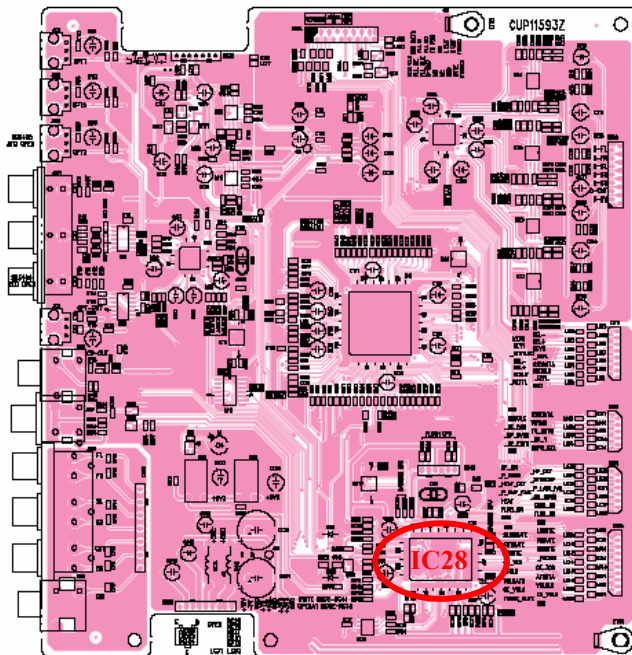
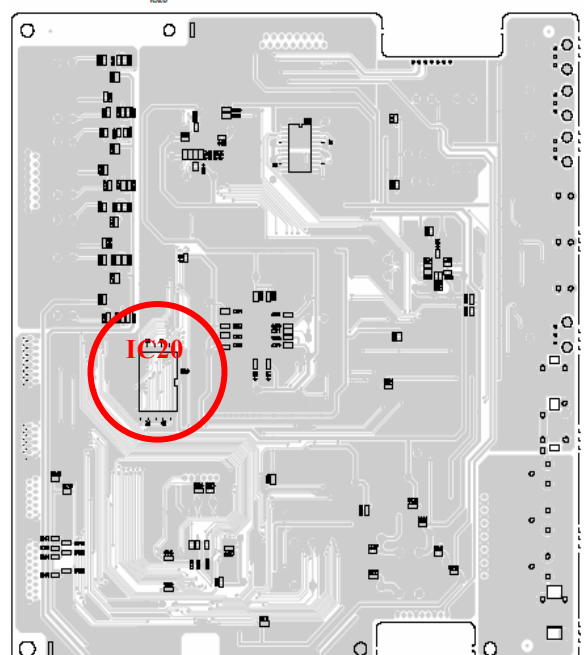
DSP PCB

V 0 4 0 4 1 2 1

CD01 02060104	CD02 02010116	CD03 02060206	CD04 02040113
CD05 02030306	CD06 02030114	CD07 02030211	CD08 02020206
CD09 02050211	CD0A 0205030A	CD0B 0205040D	CD0C 02050510
CD0D 02050110	CD0E 02050603	CD0F 00000000	CD10 00000000
CD11 00000000	CD12 00000000	CD13 00000000	CD14 00000000

1. Replace the microprocessor **IC28** on the **DSP PCB**. Version to [**V040412 1**]
2. Replace the DSP **IC20** on the **DSP PCB**. DSP Code ID to [**CD02 02010116**]
Please see to the service manual page 60 about details of "10. SERVICE MODE".

- 1. POS. No. IC28** **Part no. 90M-HS27AWH2R** **(HVIHD64F2398F20 programmed flash ROM)**
[OLD part no. * HS27AWH0R]
- 2. POS. No. IC20** **Part no. 90M-HS27AWX2R** **(HVIMX29LV400TTC programmed flash ROM)**
[OLD part no. * HS27AWX0R]
