marantz® SERVICE BULLETIN		Date: 16-July-2002	Model: PM8200,PS17, SR8200,SR9200
		Page: 1/1	REF.NBR: MZ02-013
Circulation:		Subject:	
Application:		In correct a RELAY part was used.	
x for information customer complaint in case of service mandatory			
		See Below

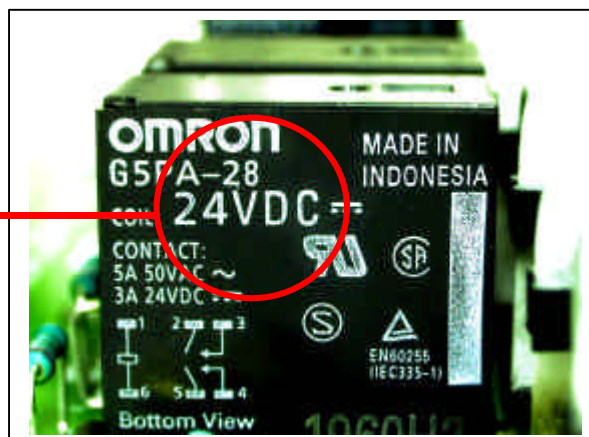
Incorrect parts mixed and were used.

Correct part 24VDC
Incorrect part 12VDC

Please exchange for the correct the part.

Correct part no **9965 000 05895** (PCS part no)

LY20240490 (MJI part no)
