MtIntosh

NL 2N LOUDSPEAKER SYSTEM

SERVICE INFORMATION

SERIAL NO. L1D001 AND ABOVE BD1509 TO BD1586

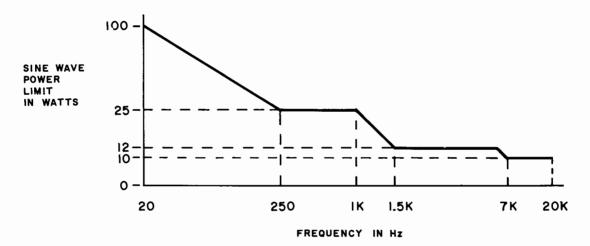
POWER HANDLING: Sine Wave steady state

Avoid operating the speaker system with sustained sine wave signals at power levels greater than the indicated limits. Permanent damage may result.

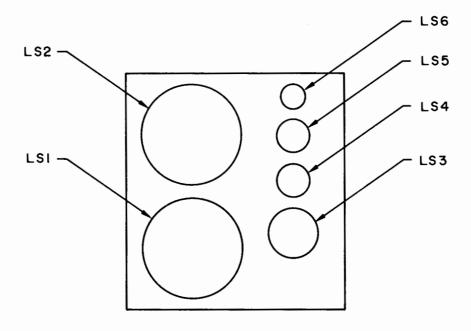
SPEAKER LOCATION

REMOVE REAR PANEL TO SERVICE CROSSOVER NETWORK

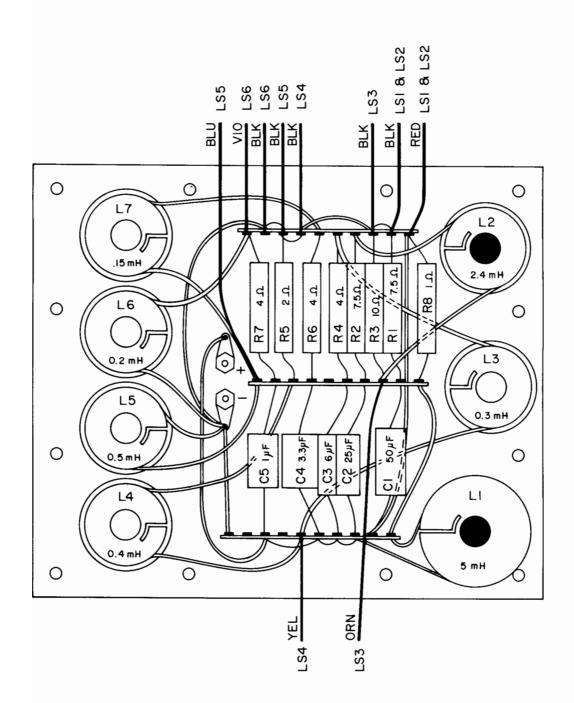
SYSTEM SCHEMATIC

SCHEMATIC NOTES

1. In early units LS6 is 036-005 16 $\!\Omega$ impedance. LS6 can be replaced with 036-012 8 $\!\Omega$ impedance. Acoustic output will be the same.

CROSSOVER NETWORK

ASSEMBLY 044-222

The crossover network must be inspected when burned out speaker elements are replaced. The network must also be inspected if a speaker element produces sound with the battery test but does not play when connected in the system. The woofer must be removed to get to the crossover. Check for bad connections, broken wires, etc. Be sure to check the resistors mounted on the plate underneath the printed circuit board. A broken lead on these resistors can also be the cause of intermittent or partial failure of the system.

When a system has been driven excessively hard by a "clipped" amplifier for long periods of time, the dome mid-range may appear to have weak or no output. In addition to a burned out mid-range, the 7µF capacitor may also be damaged. This will be evident if a new mid-range has been installed and also appears to have weak or no output.
