# NL 2N LOUDSPEAKER SYSTEM

# SERVICE INFORMATION

SERIAL NO. BD1587 AND ABOVE

### REPLACEMENT OF 8" LOUDSPEAKER 036-002

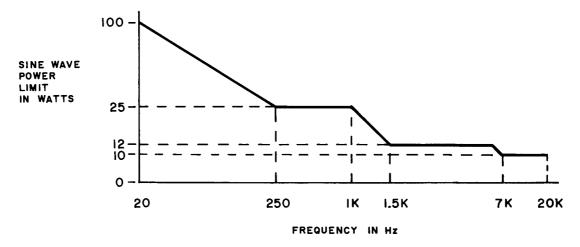
POWER HANDLING: Sine Wave steady state

Avoid operating the speaker system with sustained sine wave signals at power levels greater than the indicated limits. Permanent damage may result.

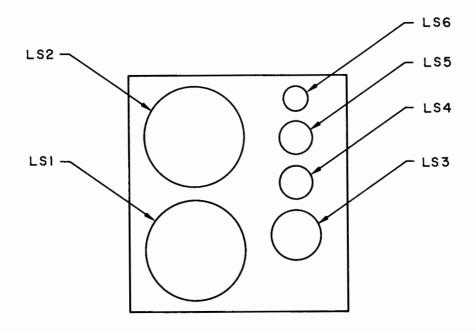
# SPEAKER LOCATION

REMOVE REAR PANEL TO SERVICE CROSSOVER NETWORK

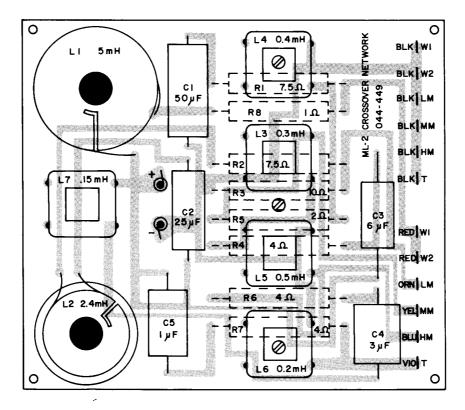
# CROSSOVER NETWORK

TWO DIFFERENT CIRCUIT BOARDS HAVE BEEN USED. THE SCHEMATIC IS THE SAME FOR BOTH.

The crossover network must be inspected when burned out speaker elements are replaced. The network must also be inspected if a speaker element produces sound with the battery test but does not play when connected in the system. The woofer must be removed to get to the crossover. Check for bad connections, broken wires, etc. Be sure to check the resistors mounted on the plate underneath the printed circuit board. A broken lead on these resistors can also be the cause of intermittent or partial failure of the system.

Use RTV silicone rubber under replacement parts mounted on the printed circuit board. In addition to the solder connections, this insures a vibration free bond to the board.

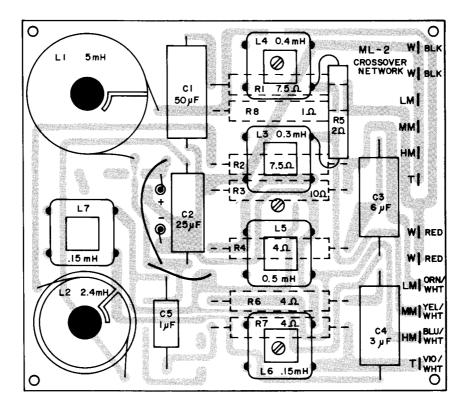
SYSTEM SCHEMATIC

- 1. In early units C4 is  $3.3\mu F$ .
- 2. In early units LS6 is 036-005 16  $\!\Omega$  impedance. LS6 can be replaced with 036-012  $8\Omega$  impedance. Acoustic output will be the same.

When a system has been driven excessively hard by a "clipped" amplifier for long periods of time, the dome mid-range may appear to have weak or no output. In addition to a burned out mid-range, the  $7\mu F$  capacitor may also be damaged. This will be evident if a new mid-range has been installed and also appears to have weak or no output.
