## Service Information

### AXIS 8

Title Numark Axis 8 Function PCB  
 Size Document Number:  
 A2 CONB/CONB-C SCH  
 Date: December 19, 2001 Sheet of 3

## PITCH AND WHEEL RECALIBRATION PROCEEDURE

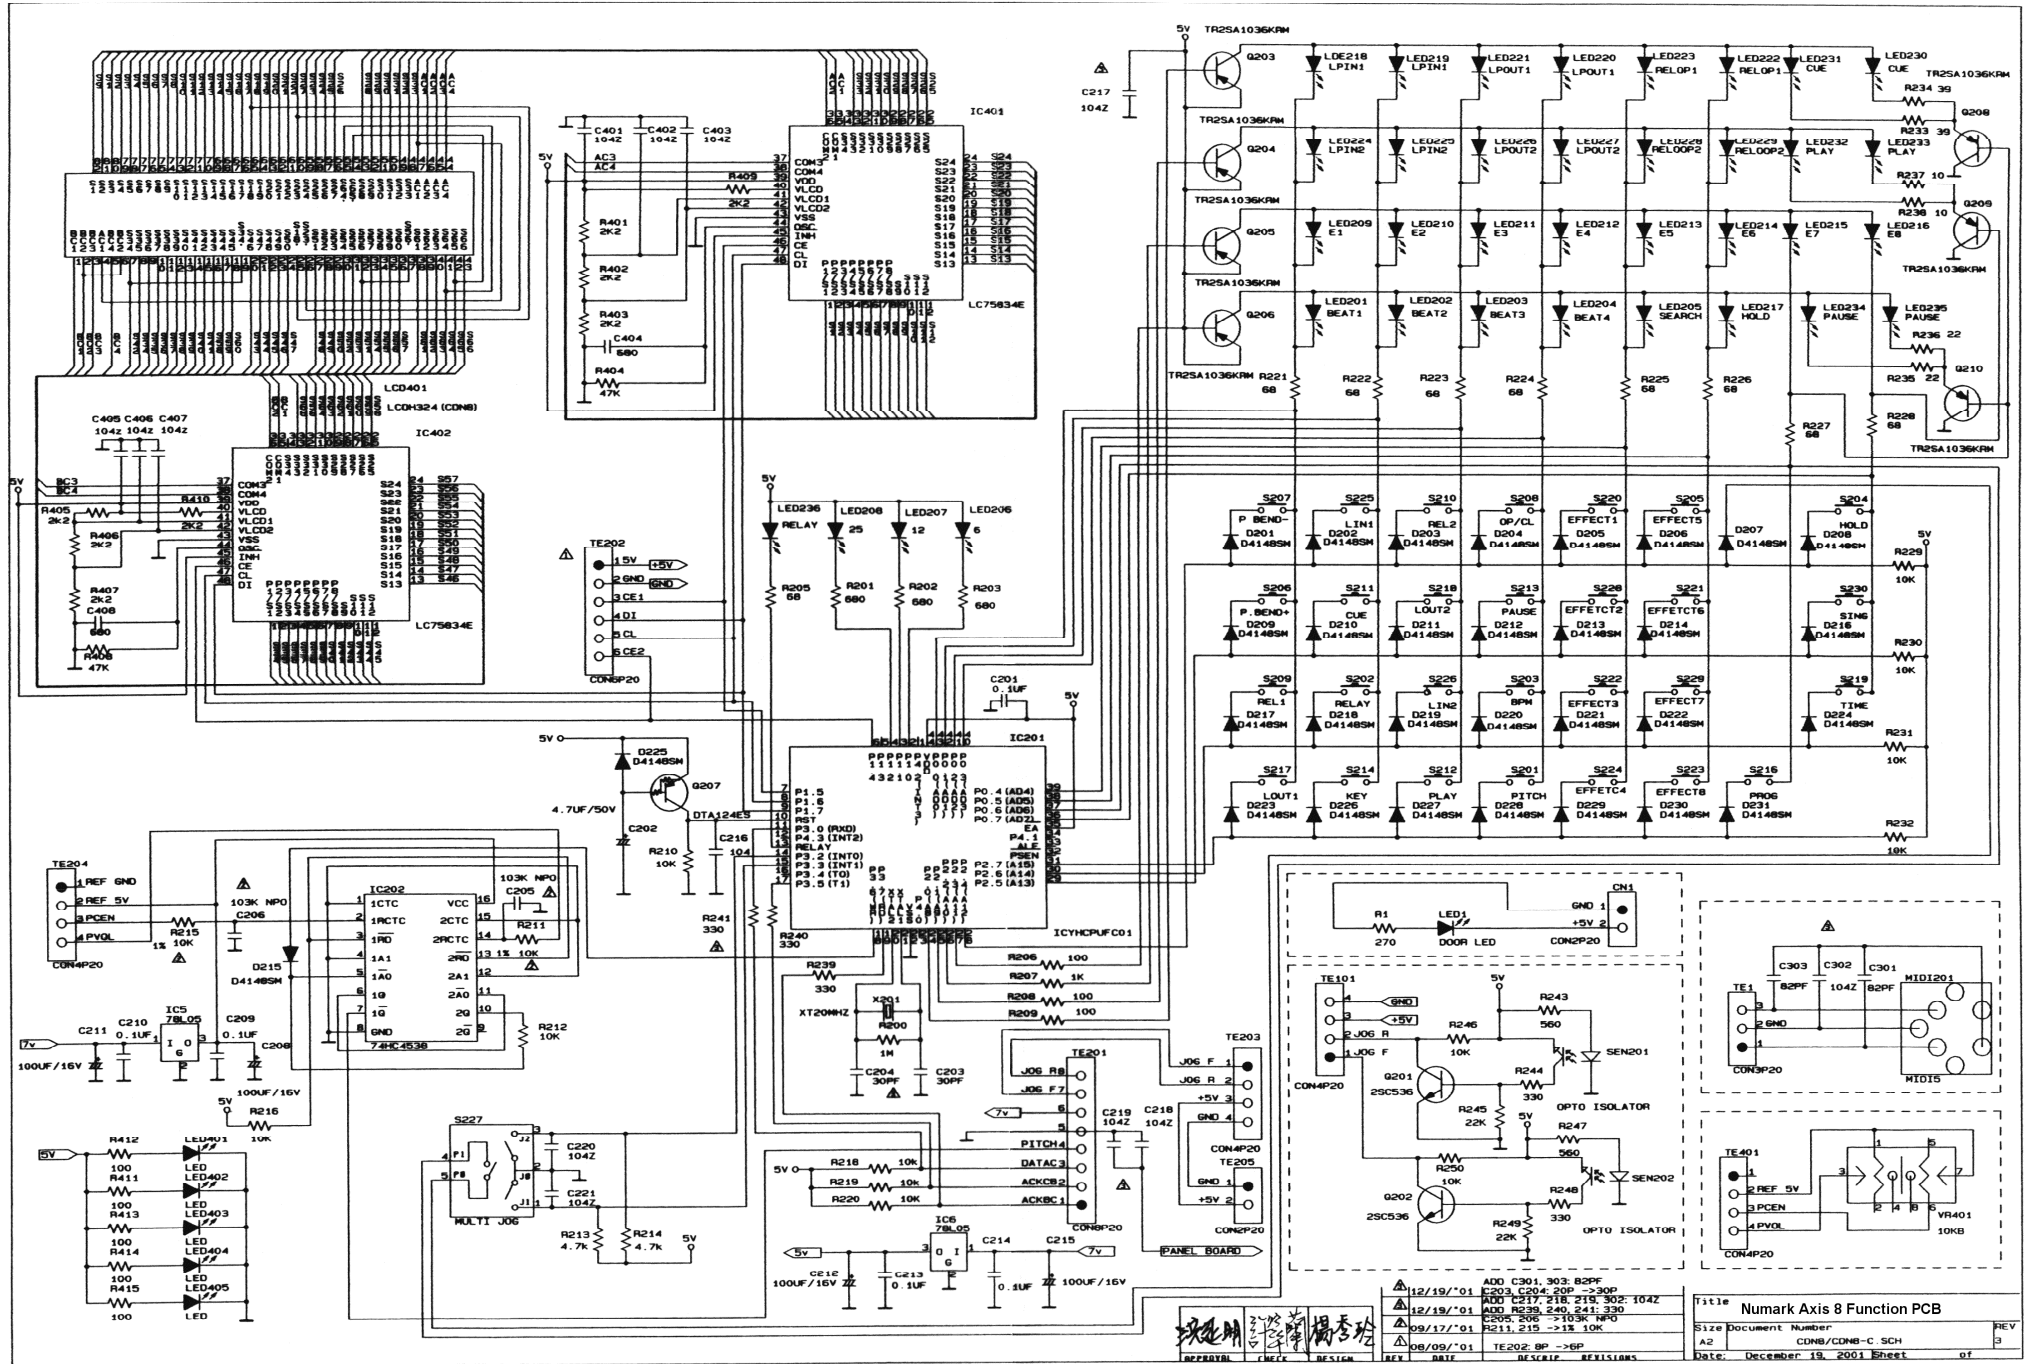
ADD C301, 302, 82PF  
 ADD C217, 218, 219, 302, 104Z  
 ADD R238, 240, 241, 330  
 C205, 206 -> 103K NPO  
 R211, 215 -> 15 10K  
 TE202, 8P -> 8P  
 TE202, 8P -> 8P

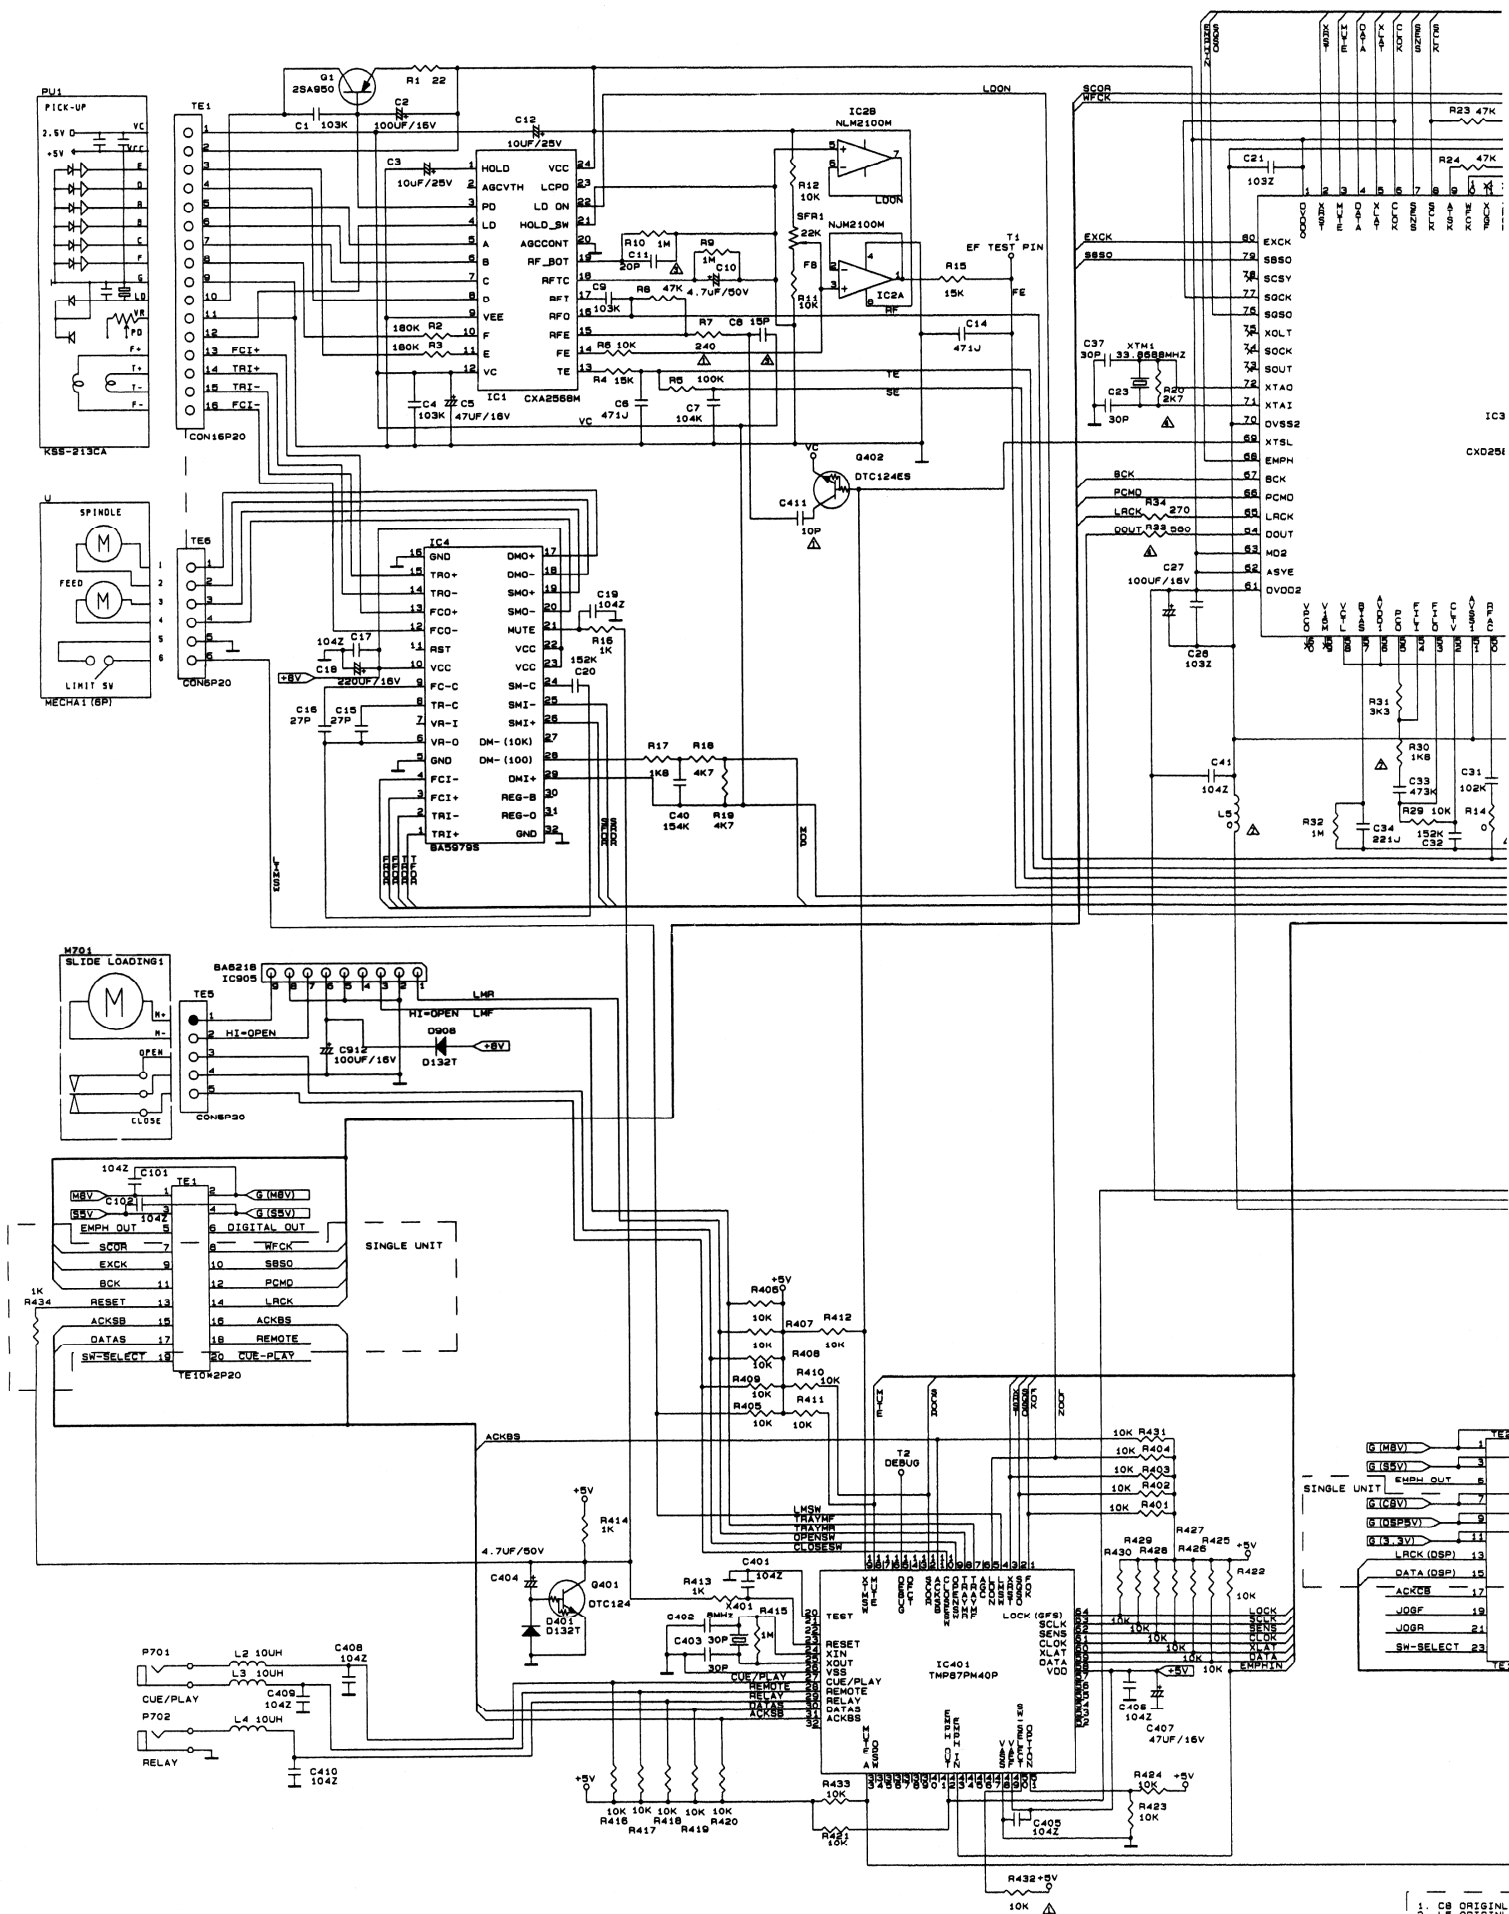
1. CB ORIGINAL  
 2. LS ORIGINAL  
 3. R30 ORIGINAL  
 4. R1 ORIGINAL  
 5. SERVO MOTOR  
 MODIFY CONN

MODIFY 2001.11

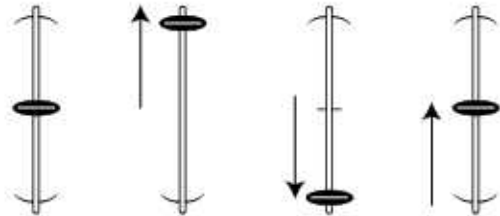
Turn on the unit with no disc inserted.

Starting from center  
Move your slider all the way negative  
then all the way positive  
then back to center
