S-8000II  
S-3000III  
S-3000IV

#### SHERWOOD SERVICE DATA BULLETIN

All S-8000II, S-3000III with serial number 3223261 and up, S-3000IV with serial number 3224501 and up

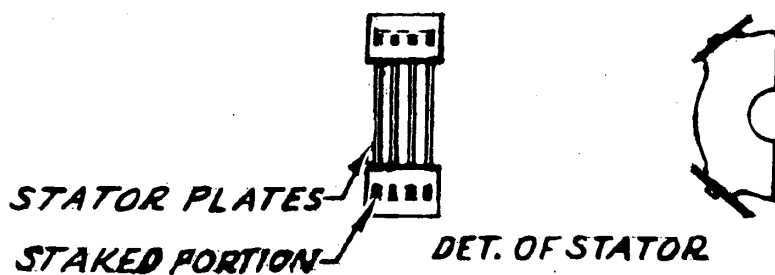
This can be detected by any one of three different methods. While looking at the I.F.'s on a scope, take a NON-METALLIC tool and applying pressure, slide the tool across the stator plates on the oscillator section of the tuning gang. If the I.F. pattern shifts and at the same time the oscillator grid voltage drops or rises along with the tuning eye opening. This indicates a defective tuning gang, Part number B125L4

OSCILLATING PORTION OF  
TUNING GANG

1. heat and break solder connections on oscillator stator plates front and back.
2. remove oscillator stator plates completely.
3. place on bench, exposing bottom of stator plates. run solder over portion of plates where it is staked (NOTE:) stator plates are aluminum and will not take solder, but solder can be flowed around aluminum plate.

4. re-install stator plates and solder in place
5. re. log.
