# THORENS

## SERVICE MANUAL

MODELS: TD-145 Series I  
TD-160 Series I  
TD-165 Series I

TD-145 MKII Isotrack  
TD-160 MKII Isotrack  
TD-166 MKII Isotrack

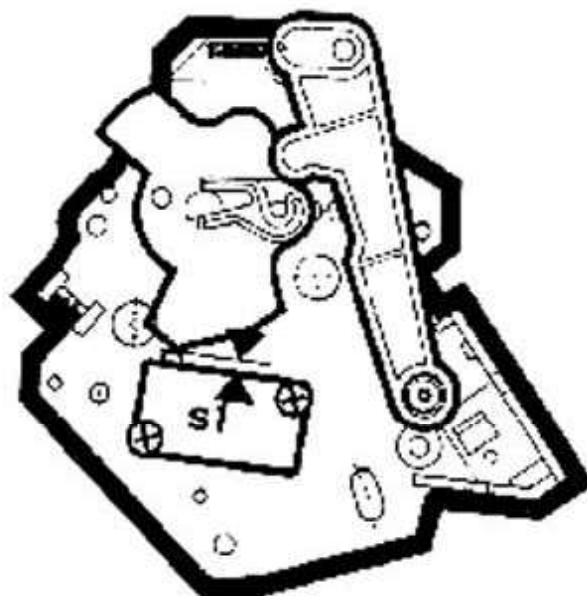
Switch adjustments; If it becomes necessary to adjust the switches, there is a defined value of clearance associated with each function switch.

Remove the hardboard bottom cover. The micro switch S-1 associated with the speed selection control must have a clearance of 0.8mm between the actuating arm and the body of the switch when the speed selection control is in the "STOP" position.
