SERVICE MANUAL

TD-145 Series I MODELS:

TD-160 Series I TD-165 Series I

TD-145 MKII Isotrack TD-160 MKII Isotrack TD-166 MKII Isotrack

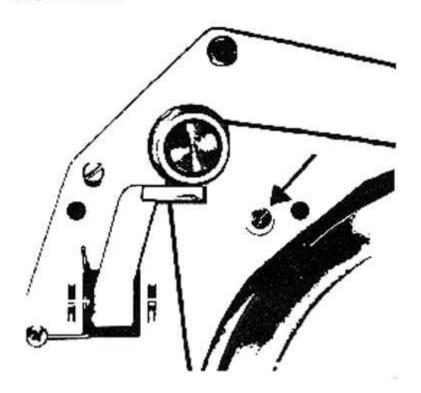
MOTOR AZIMUTH

If upon starting, stopping or interrupting the turntable rotation the rubber belt rides up or down and slips off the motor pulley, the motor azimuth may require adjustment.

The motor azimuth adjustment brings the axis of the motor pulley in parallel alignment with the axis of the inner turntable platter. To correct the motor azimuth rotate the azimuth screw (arrow). This adjustment is sealed by the factory with a dab of fast drying paint to secure the adjustment.

If the rubber belt rides up on the motor pulley rotate the azimuth screw counterclockwise.

If the rubber belt rides down the motor pulley rotate the azimuth screw clockwise.

Once the azimuth adjustment has been set reseal the screw with a dab of nail polish or fast drying paint.

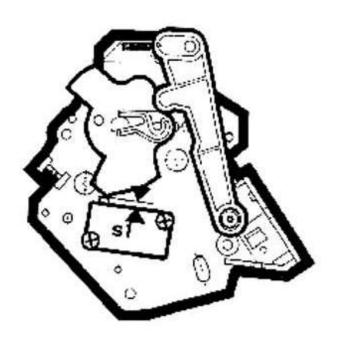
SERVICE ADJUSTMENTS

Switch adjustments; If it becomes necessary to adjust the switches, there is a defined value of clearance associated with each function switch.

Remove the hardboard bottom cover. The micro switch S-1 associated with the speed selection control must have a clearance of 0.8mm between theactuating arm and the body of the switch when the speed selection control is in the "STOP" position.
