# THORENS

## SERVICE MANUAL

MODELS:	TD-145	Series I
	TD-160	Series I
	TD-165	Series I
	TD-145	MKII Isotrack
	TD-160	MKII Isotrack
	TD-166	MKII Isotrack

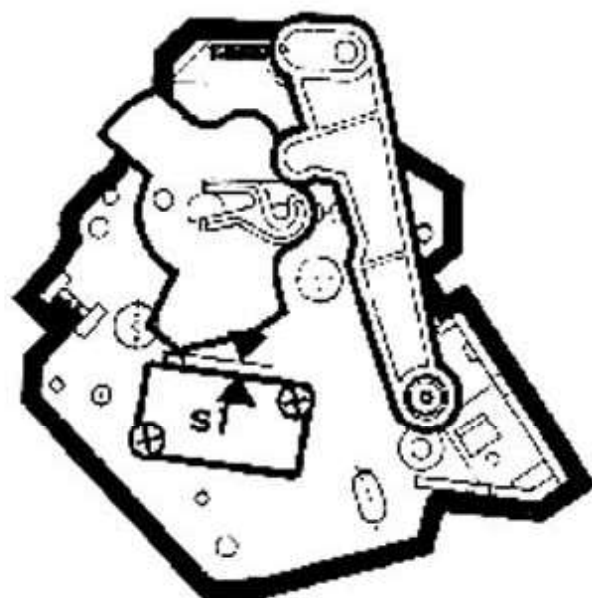
Switch adjustments; If it becomes necessary to adjust the switches, there is a defined value of clearance associated with each function switch.

Remove the hardboard bottom cover. The micro switch S-1 associated with the speed selection control must have a clearance of 0.8mm between the actuating arm and the body of the switch when the speed selection control is in the "STOP" position.
